PLAY AREA SAFETY INSPECTION REPORT

Chideock Parish Council

Park Name: Mill Lane
Location: Mill Lane, Chideock. DT6 6JS

Inspection undertaken March 2024
This report issued 24th March 2024

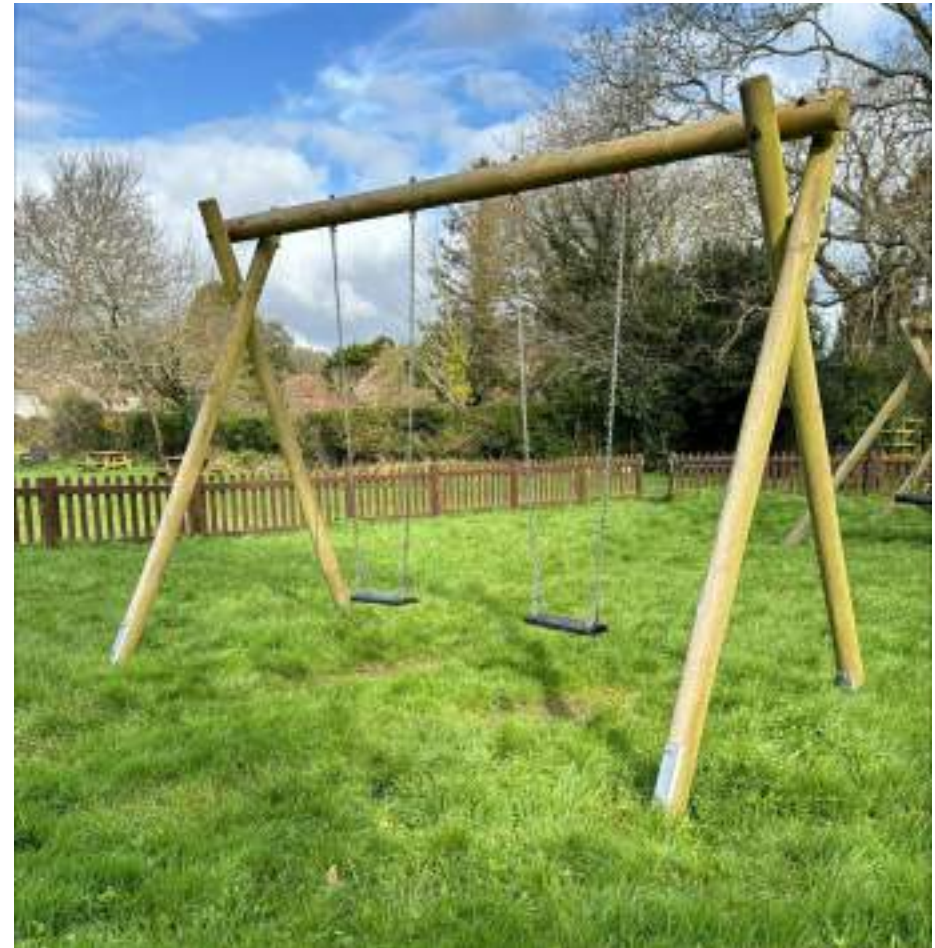
4.1 *Twin Junior Swing Set*

This item is in reasonable condition.

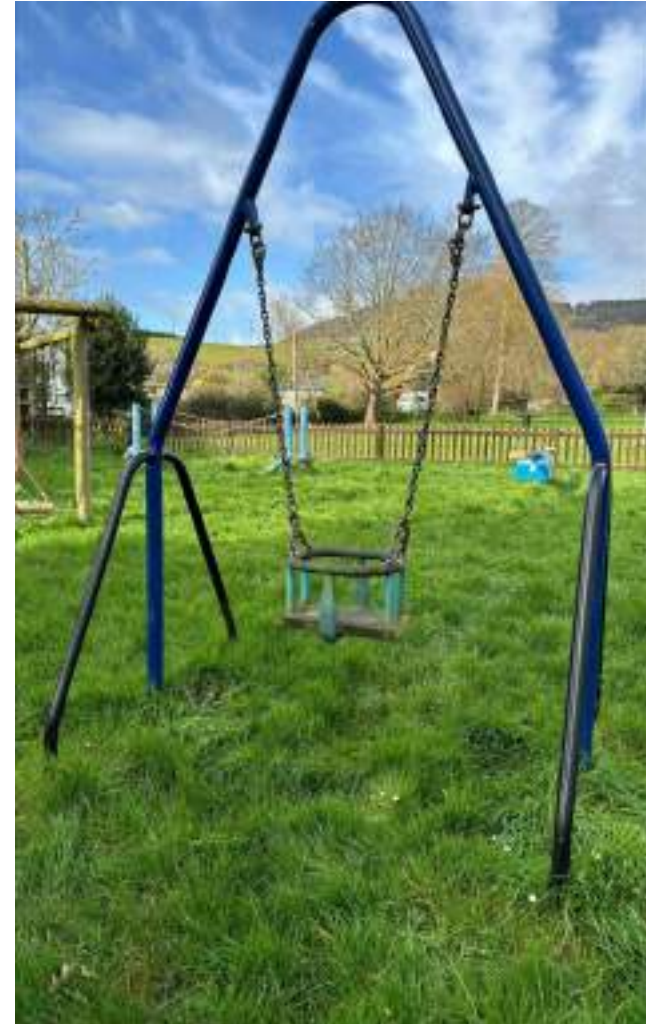
4.2 Toddler Swing

This item is in reasonable condition but plans should be made to replace the seat in the next 9-12 months.

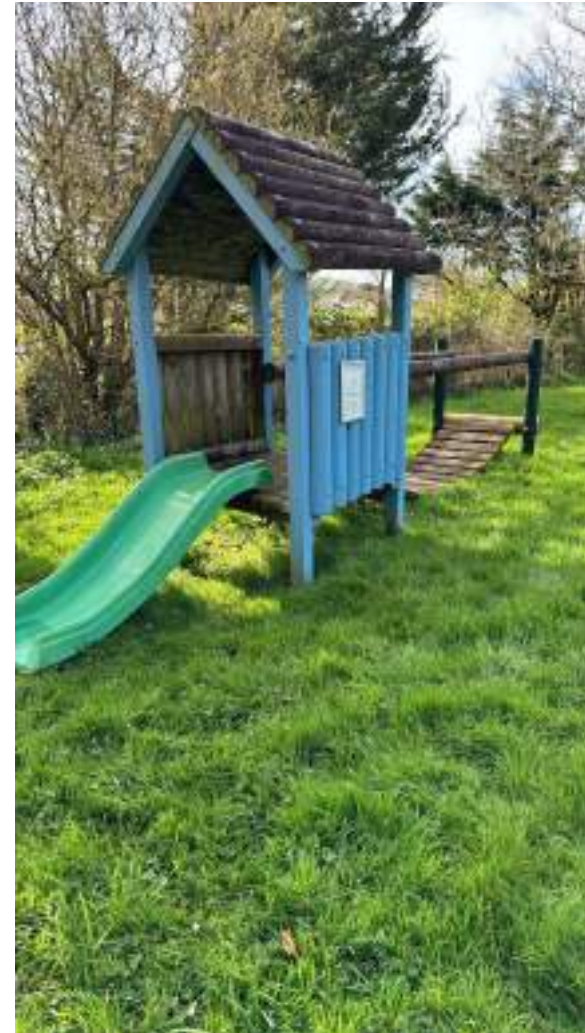
4.3 *Playhouse with bridge & Slide*

This item is in reasonable condition for its age.

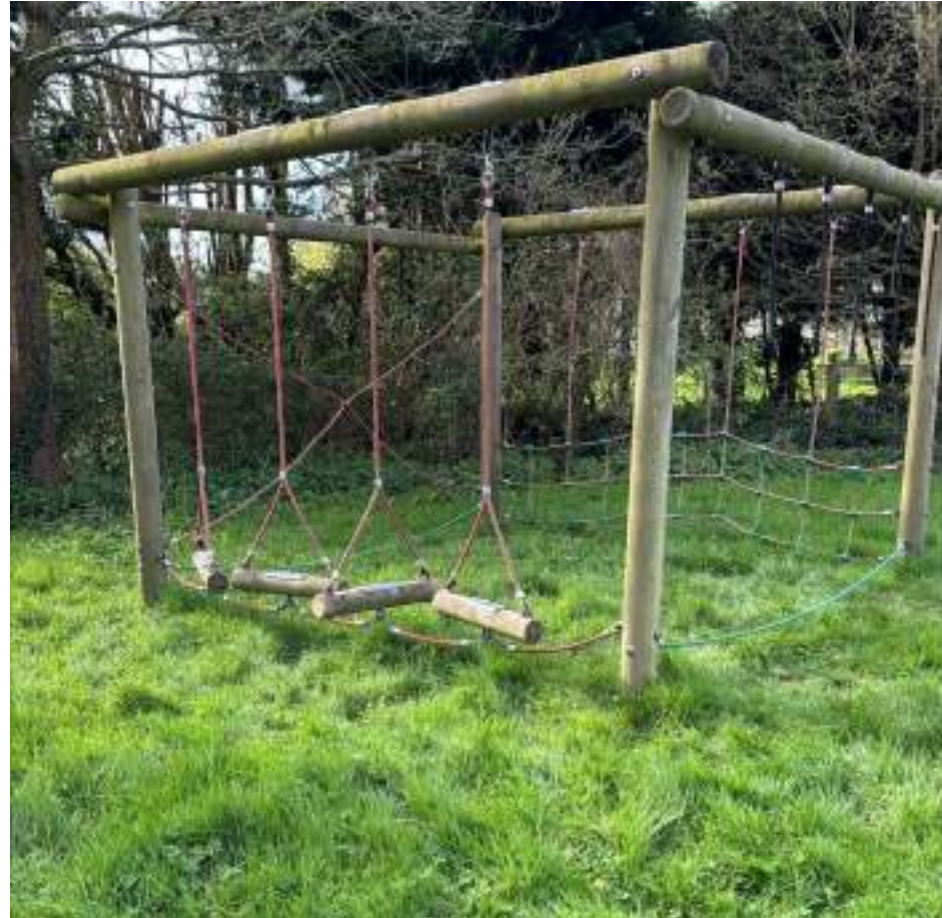
4.4 Sovereign Agility Cube

There are no issues with this unit.

Timber elements should be regularly treated against decay and this item is overdue.

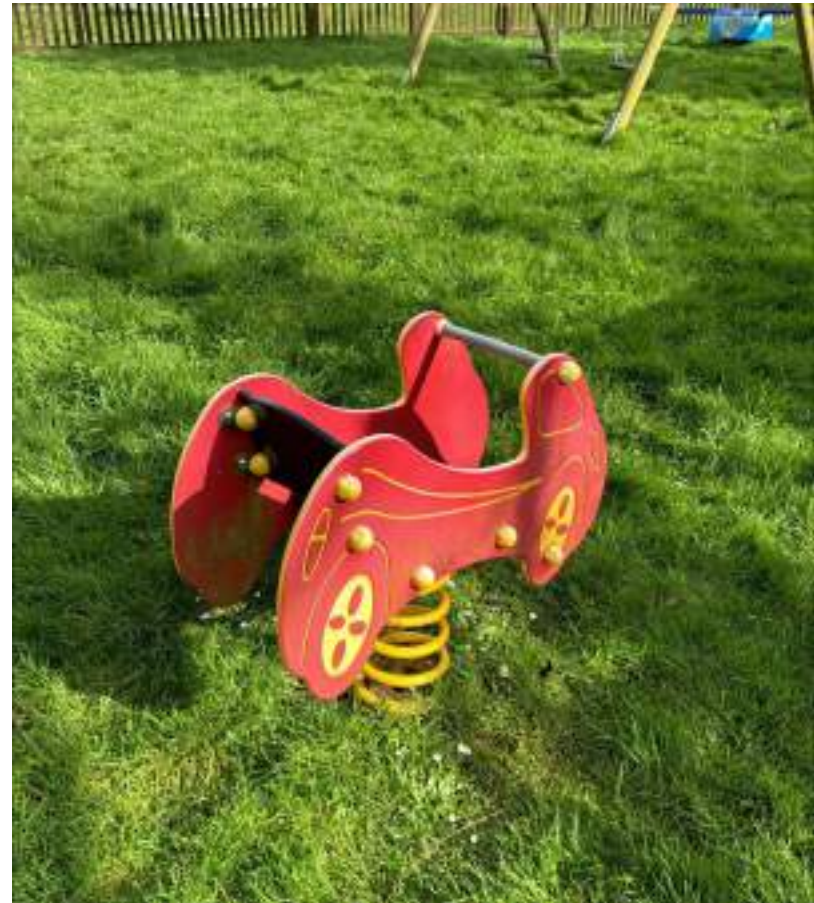
4.5 *Sit in Car Springer*

Item	Issues	Recommendation (s)
4.5	The decay in the springer base plate will lead to product failure	Plan for removal and replacement within 2.5 years / possibility of replacement of parts only.
4.8	Timbers are decaying	Replace older timber elements within 2 years. Treat all existing timbers

There is a great of corrosion on the base plates for this unit.
Replacement of these components is possible.

Item	Issues	Recommendation (s)	Supply Only	Supply & fit
4.5	Springer corroding	Replace parts		POA
4.8	Original timbers decaying	Supply and fit new timbers to Burmese bridge		POA

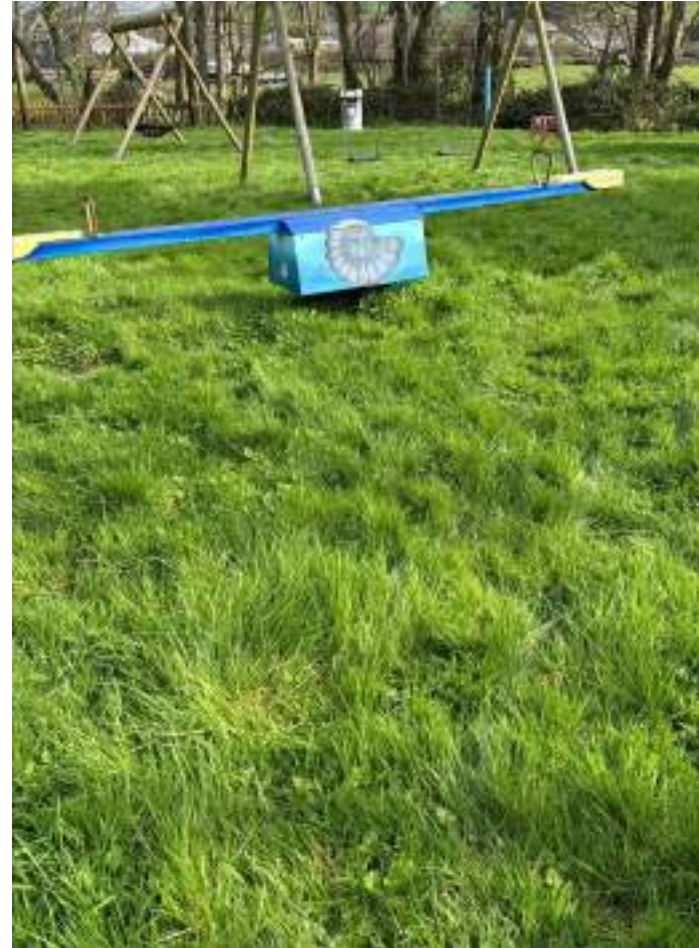
4.6 Wicksteed See saw

This item is in reasonable condition.

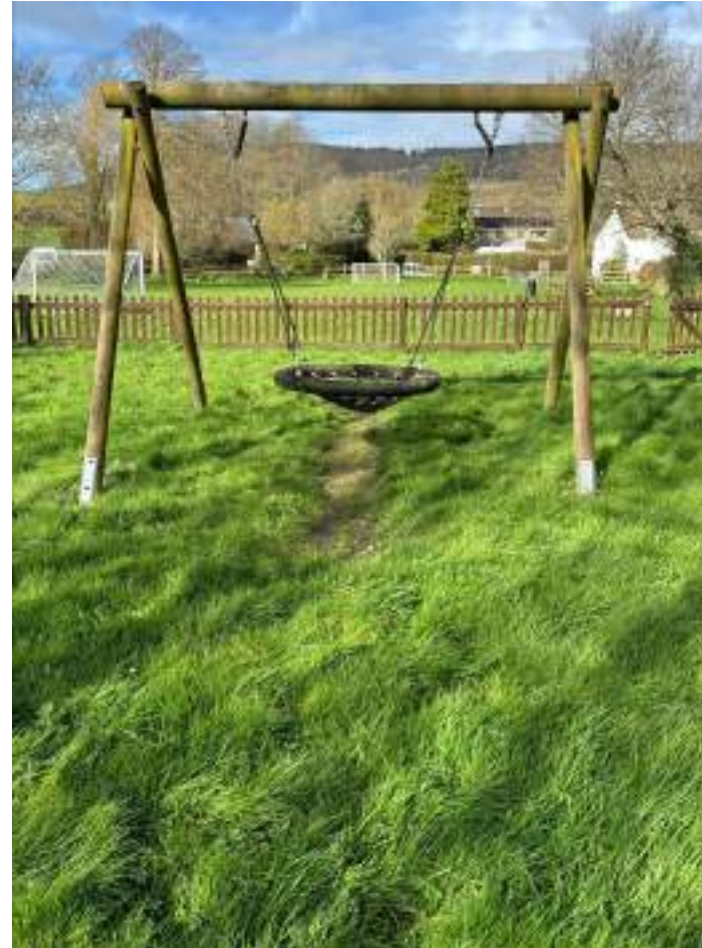
4.7 *Caledonian Play Basket Swing*

This item is in good condition.

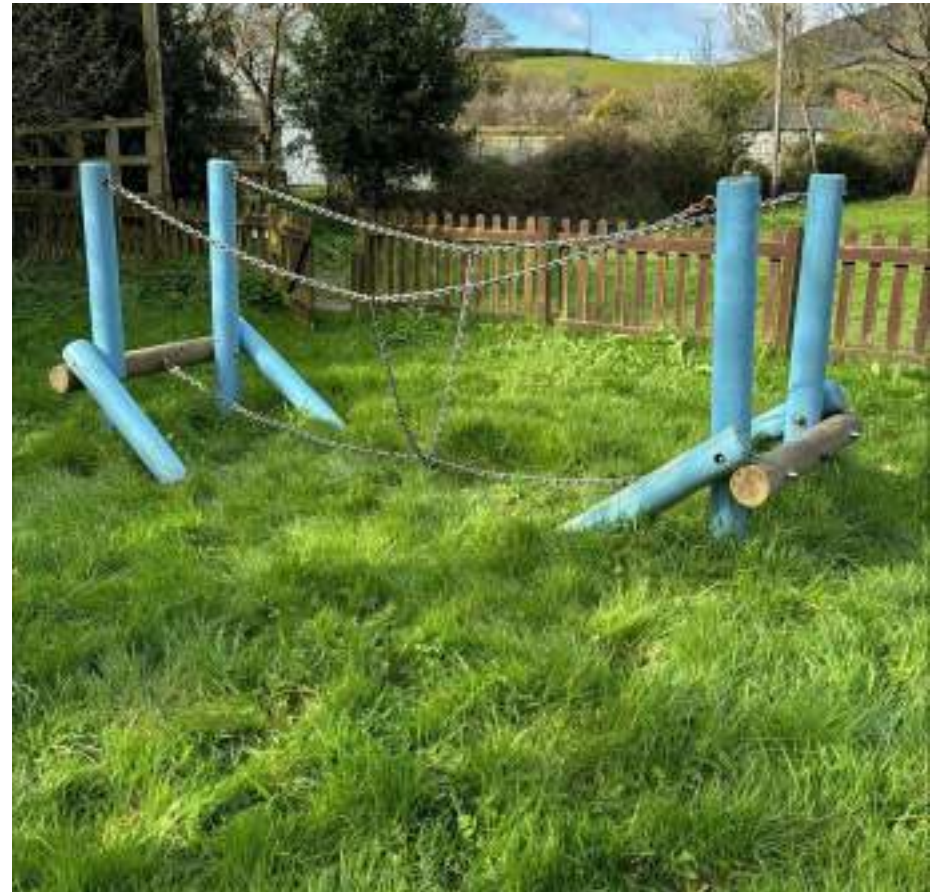
4.8 *Playquest Burmese Bridge*

There are no issues with this item.

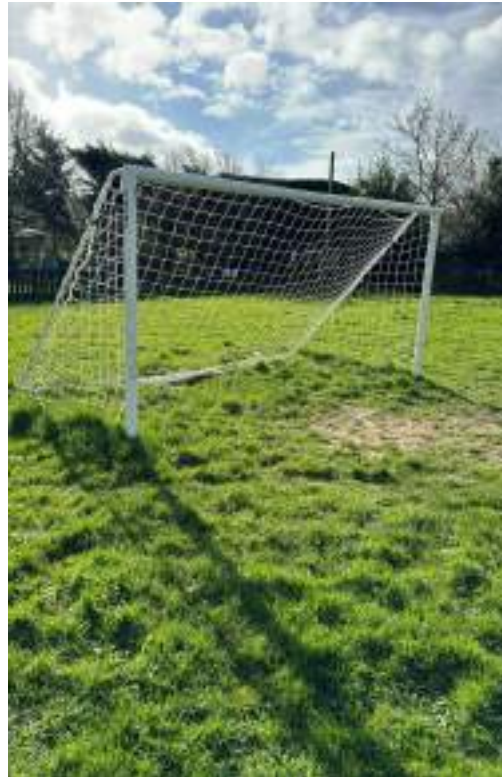
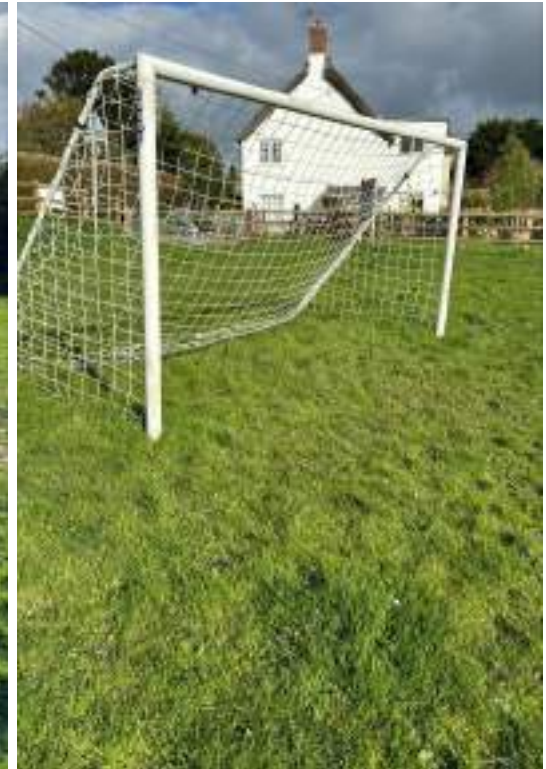
4.9 Goalposts

These newly installed goalposts are in excellent condition.

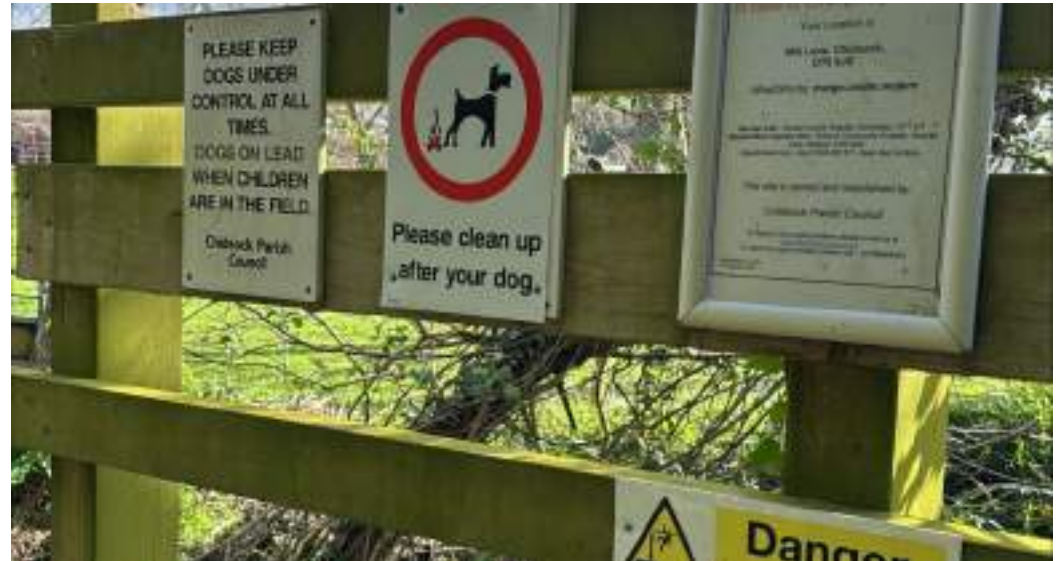
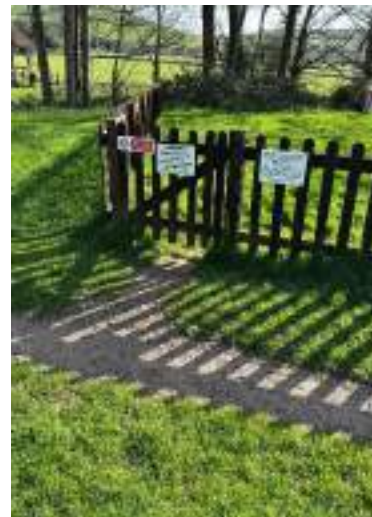
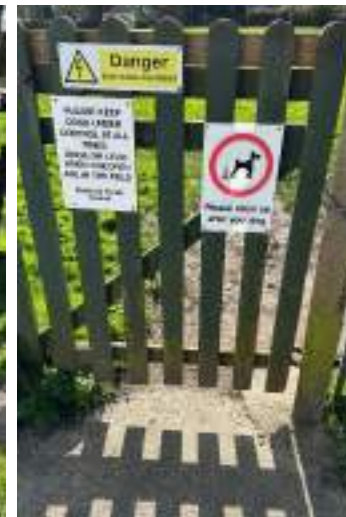
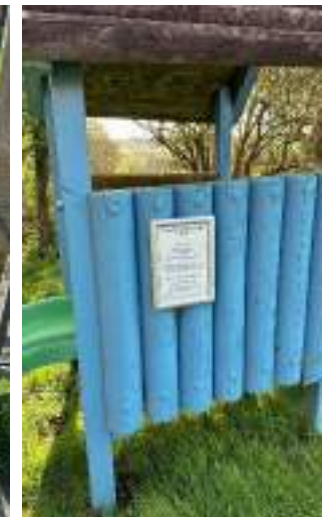
4.10 Signs

Suitable signage is in place.

Warnings against deep water and overhead power cables are also present.

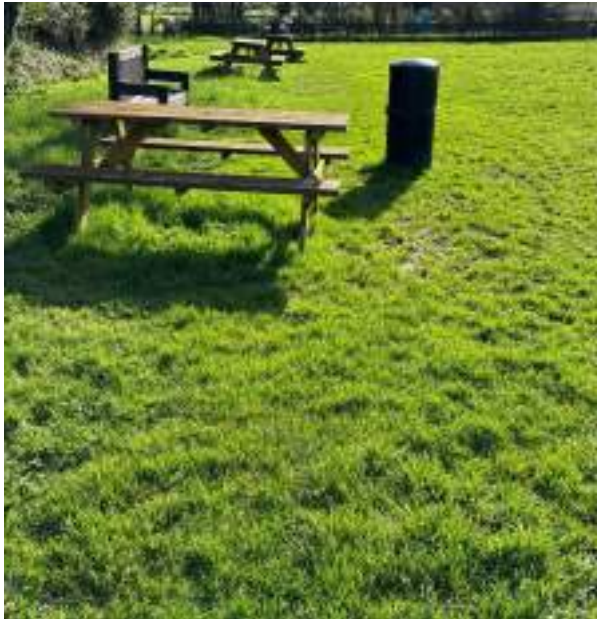
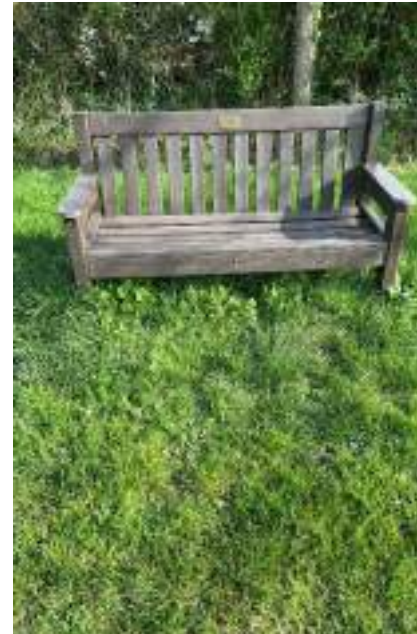
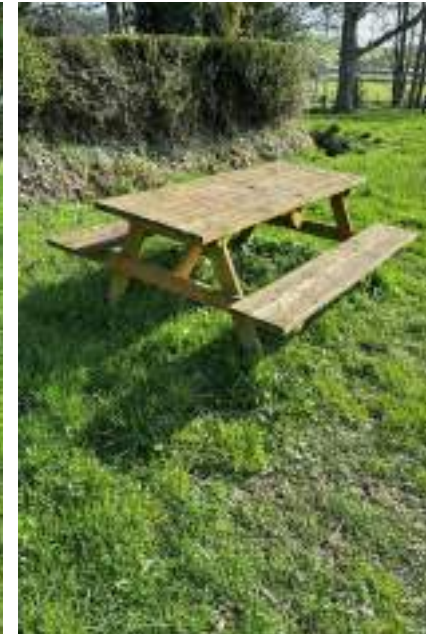
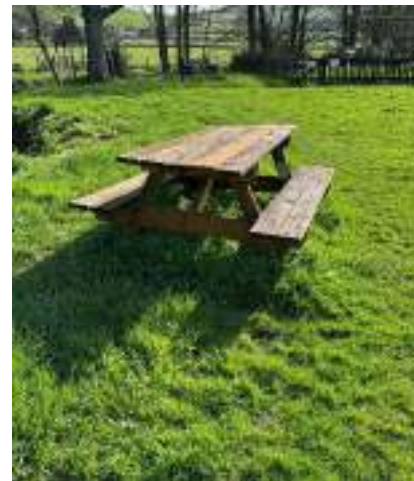
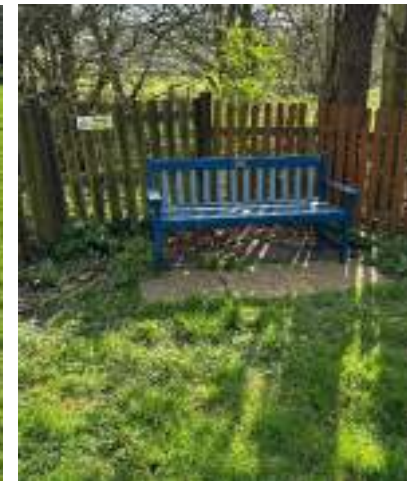
4.11 Barriers, Boundaries, Benches & Bins

The gates are self-closing, and the mechanism is working effectively.

There are several nearby bins and a variety of benches around the site in reasonable condition.
