PLAY AREA SAFETY INSPECTION REPORT

Chideock Parish Council

Inspection undertaken March 2023
This report issued March 26th 2023

Park Name: Mill Lane
Location: Mill Lane, Chideock. DT6 6JS

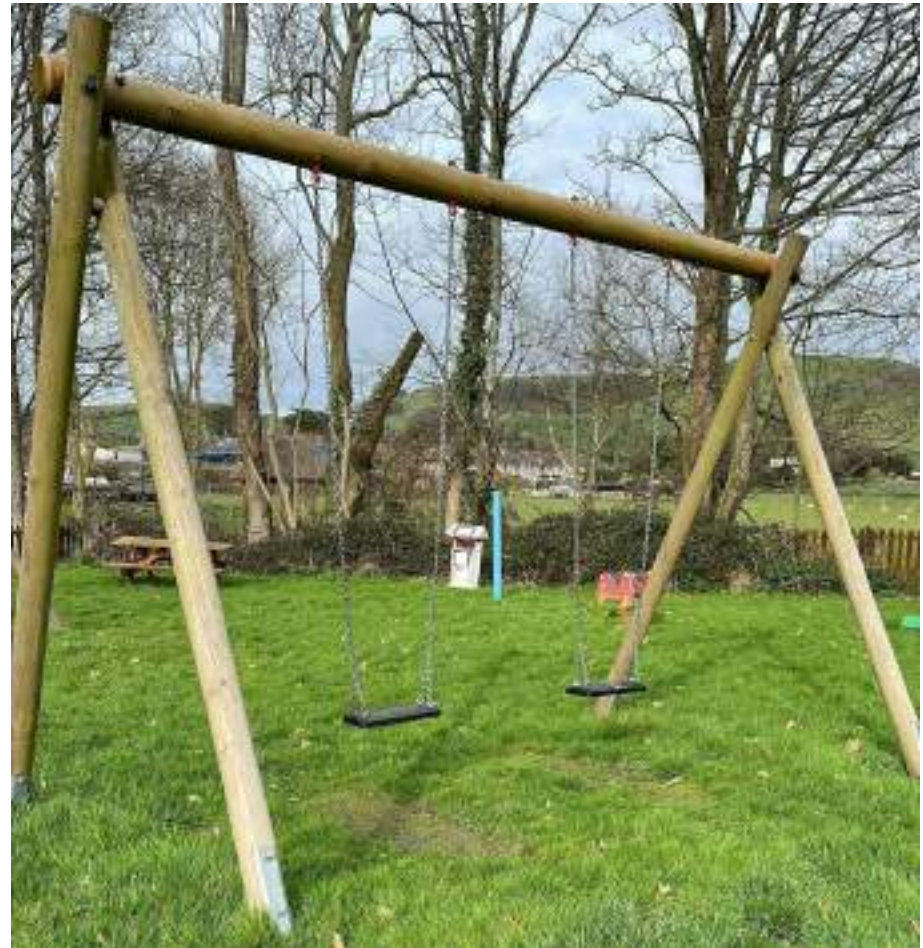
4.1 *Twin Junior Swing Set*

This item is in reasonable condition.

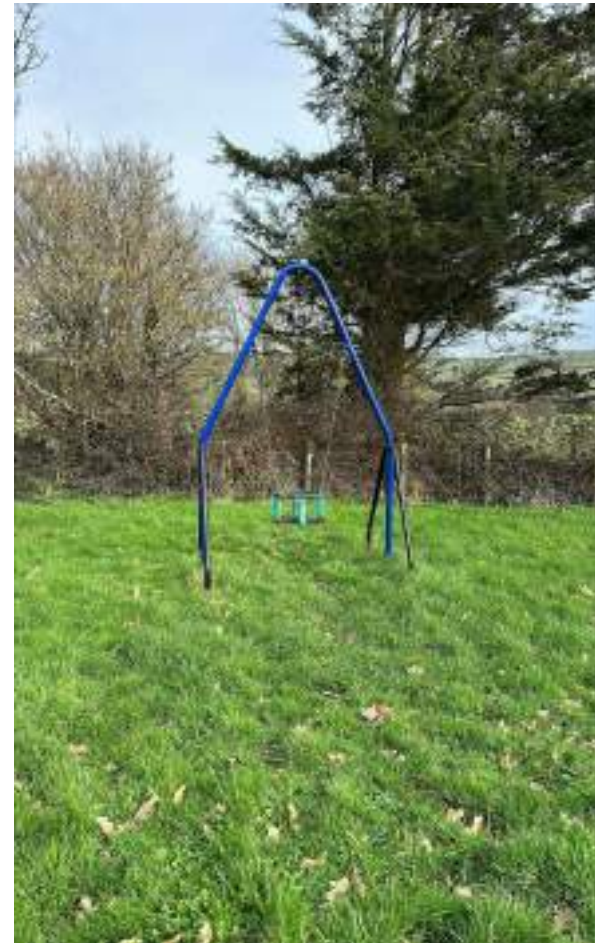
4.2 Toddler Swing

This traditional frame from Wicksteeds' heritage range is old but in good condition. The gate latch links are in reasonable condition with sufficient links on the outside.

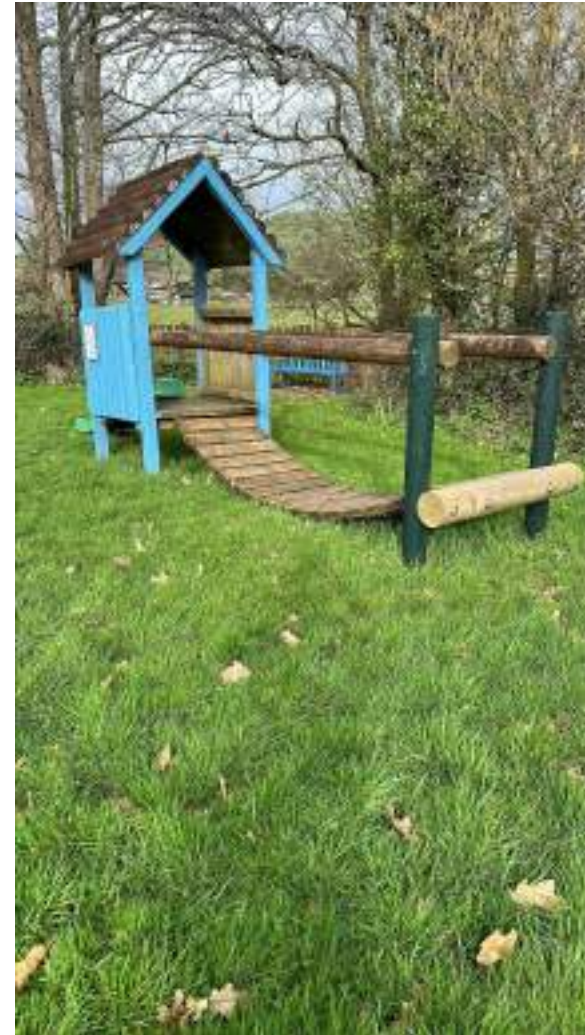
4.3 *Playhouse with bridge & Slide*

This item is in reasonable condition for its age.

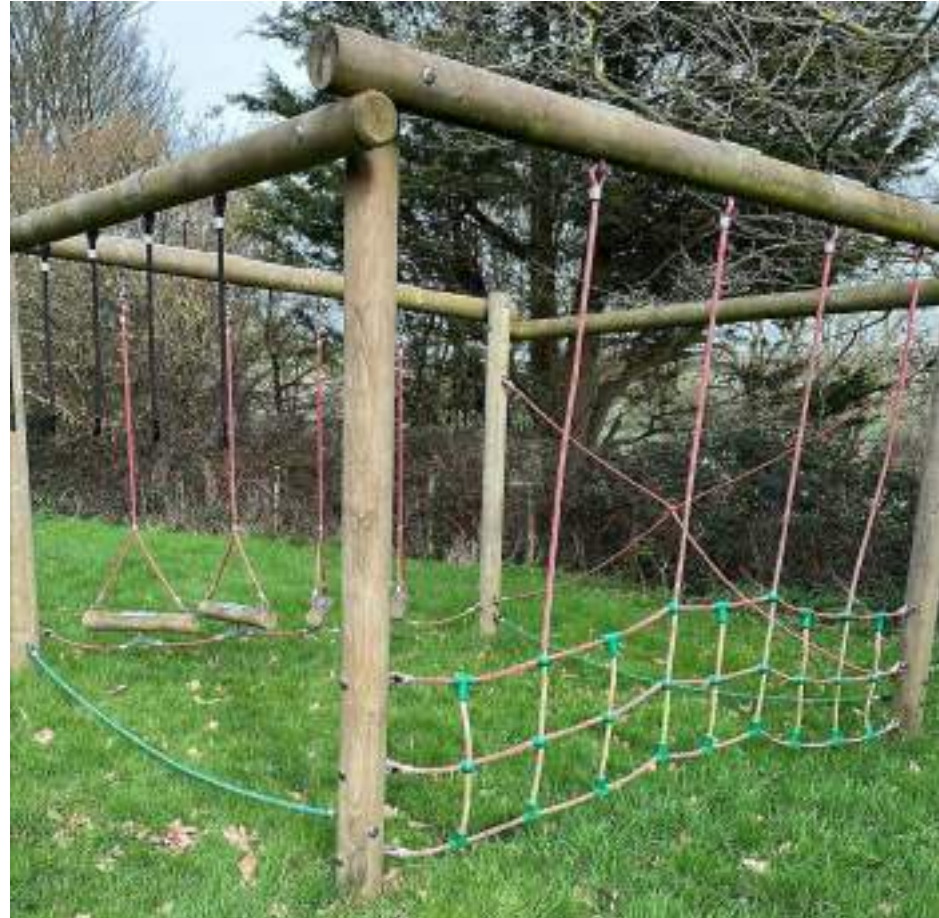
4.4 Sovereign Agility Cube

There are no issues with this unit.

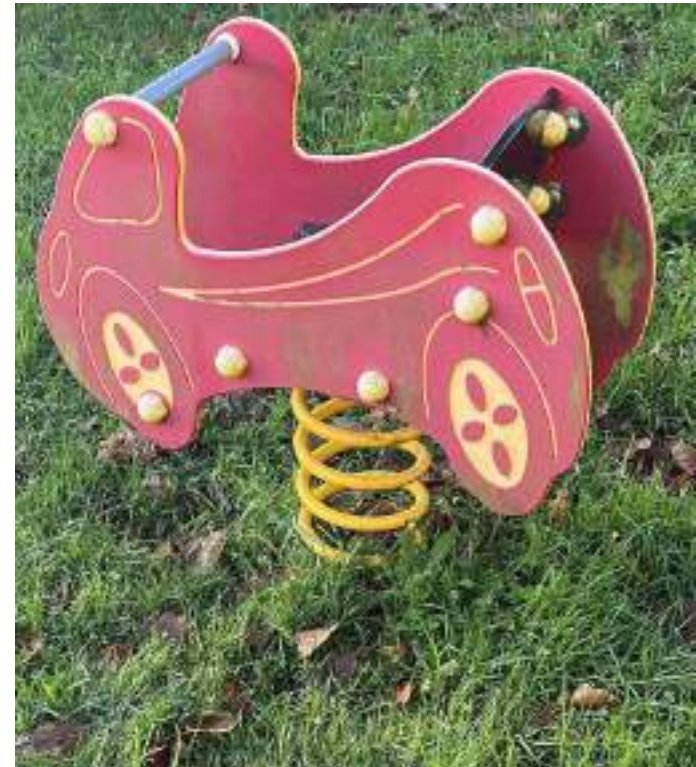
4.5 *Sit in Car Springer*

There is a great of corrosion on the base plates for this unit. Replacement of these components is possible and costs are shown at 5.

Item	Issues	Recommendation (s)
4.5	The decay in the springer base plate will lead to product failure	Plan for removal and replacement within 2.5 years / possibility of replacement of parts only.
4.8	Timbers are decaying	Replace older timber elements within 2 years. Treat all existing timbers

Item	Issues	Recommendation (s)	Supply Only	Supply & fit
4.5	Springer corroding	Replace parts		£450.00
4.8	Original timbers decaying	Supply and fit new timbers to Burmese bridge		POA

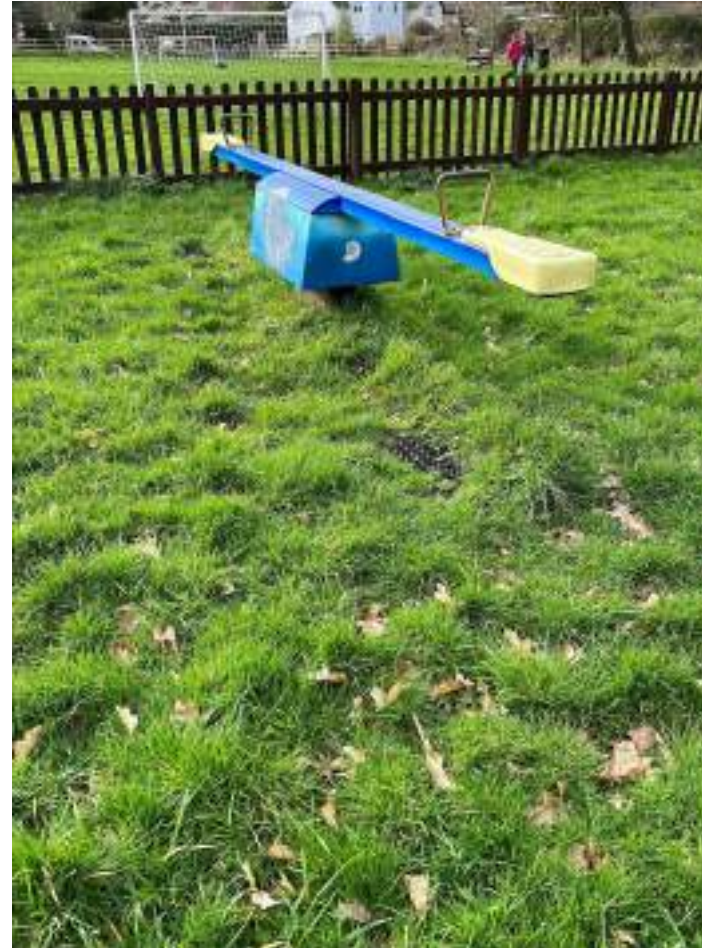
4.6 **Wicksteed See saw**

This Wicksteed see-saw is still in good working order.

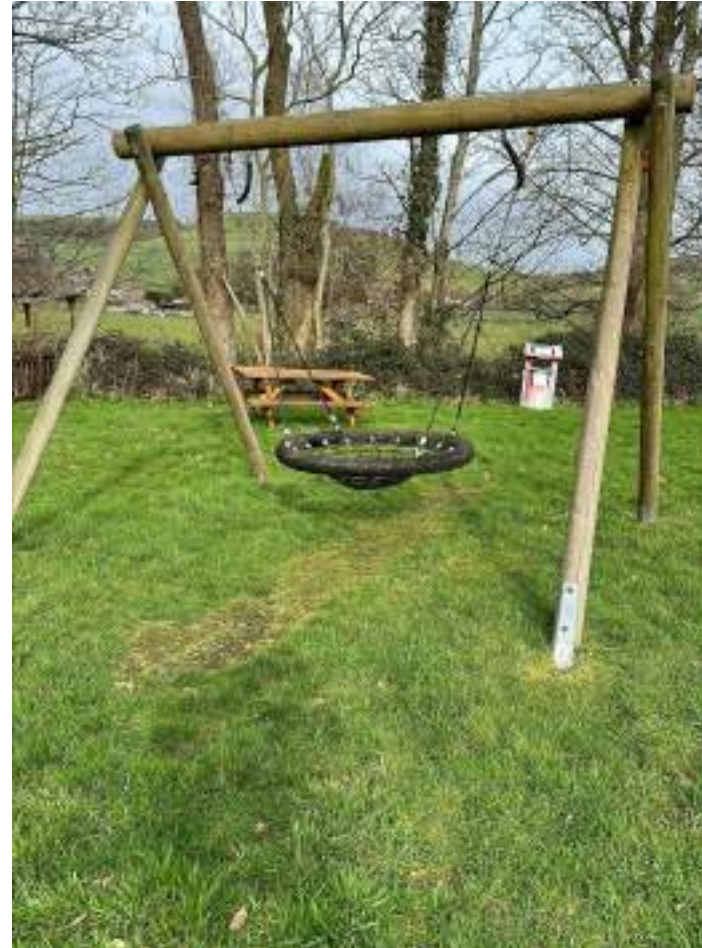
4.7 *Caledonian Play Basket Swing*

This item is in good condition.

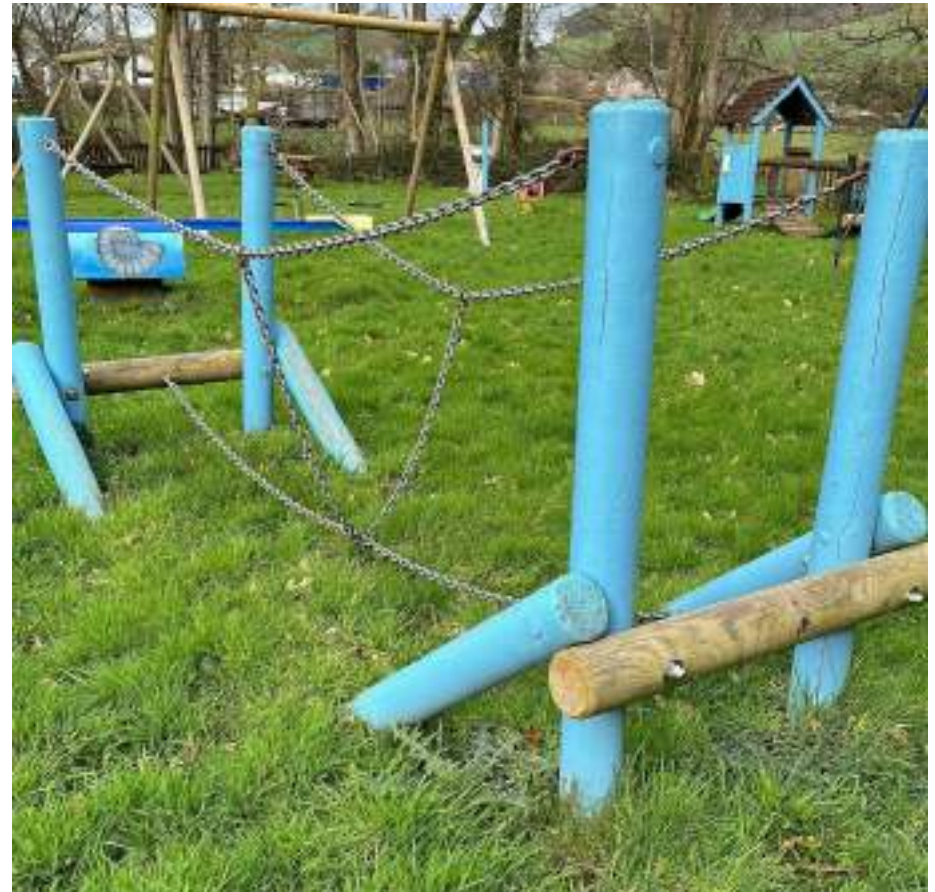
4.8 *Playquest Burmese Bridge*

This item is in reasonable condition for its age, but the remaining timbers will need replacing soon.

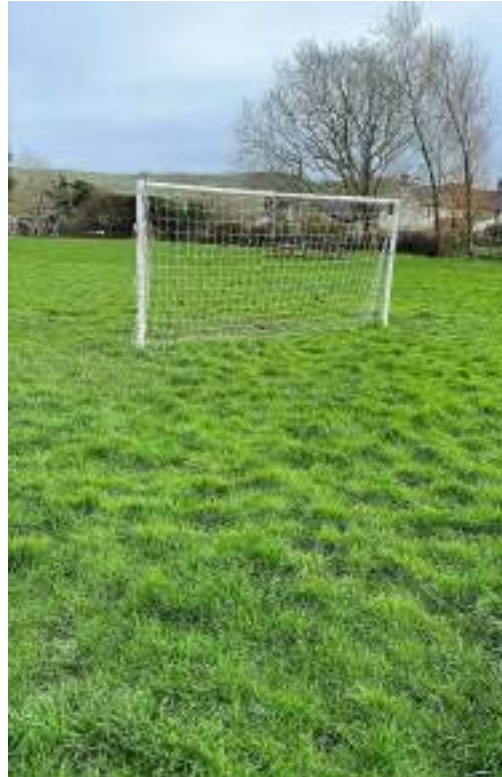
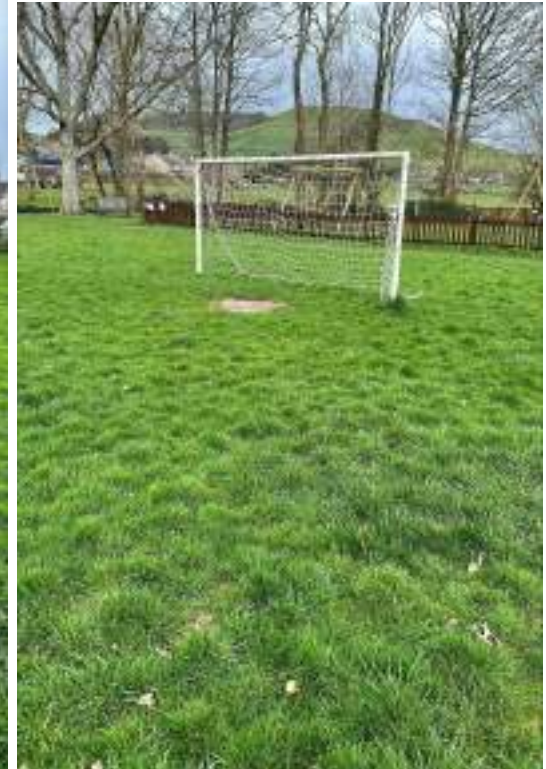
4.9 Goalposts

This will resolve the frequent issues with unpegged nets.

The goals are due to be replaced with a fixed net style set.

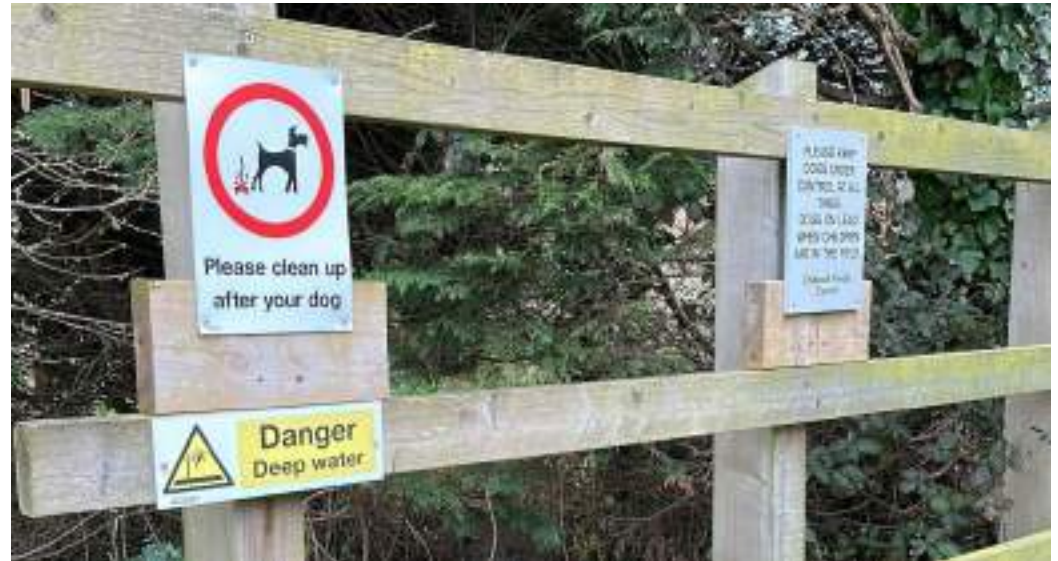
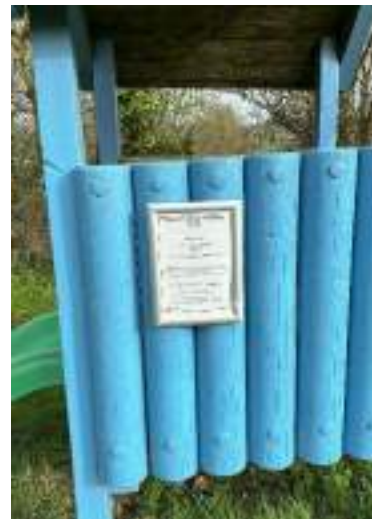
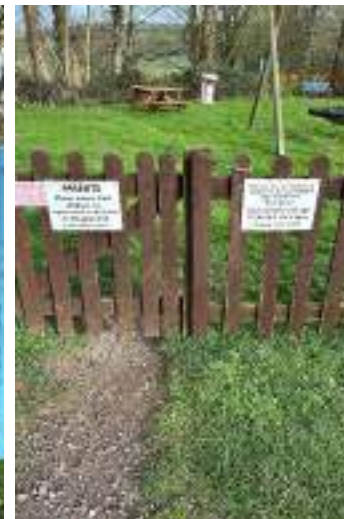
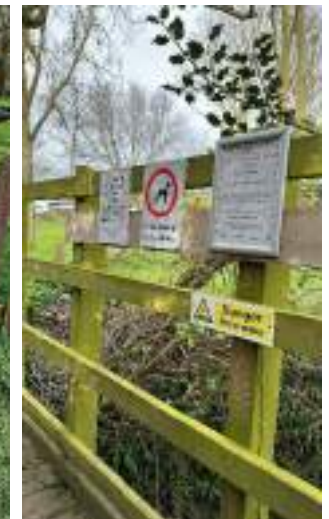
4.10 Signs

Suitable signage is in place.

Warnings against deep water and overhead power cables are also present.

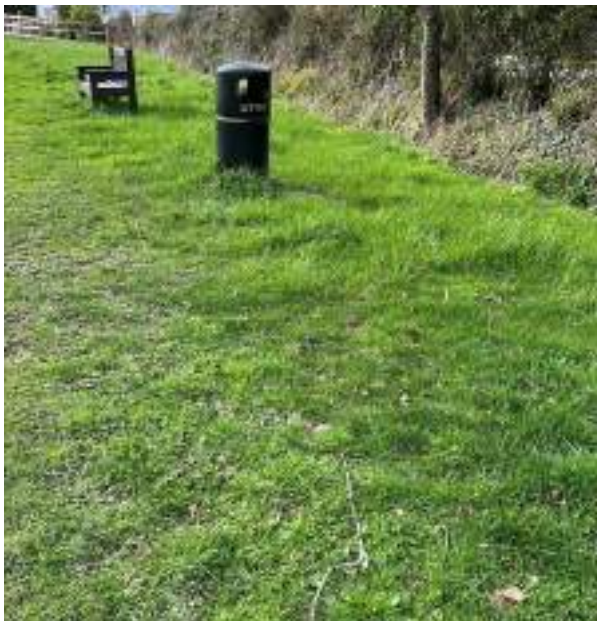
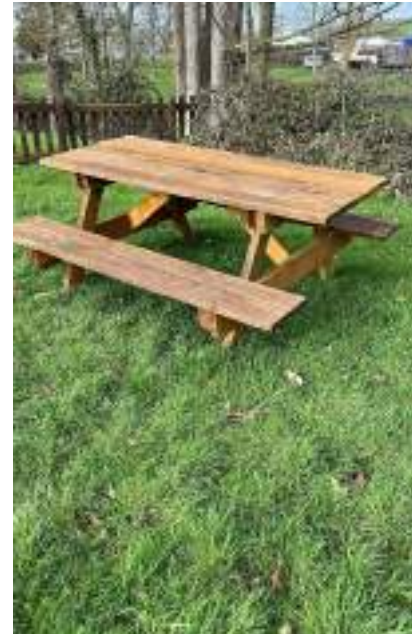
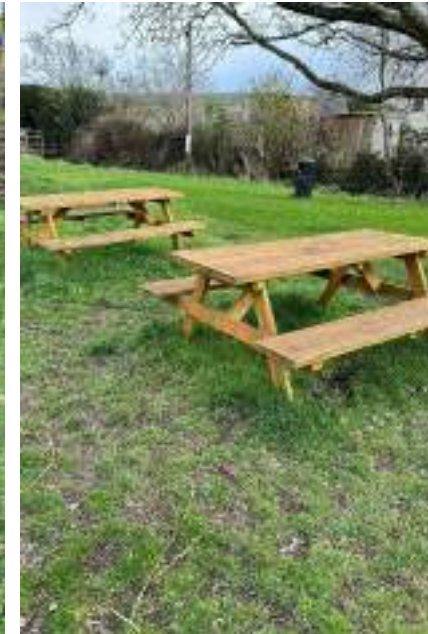
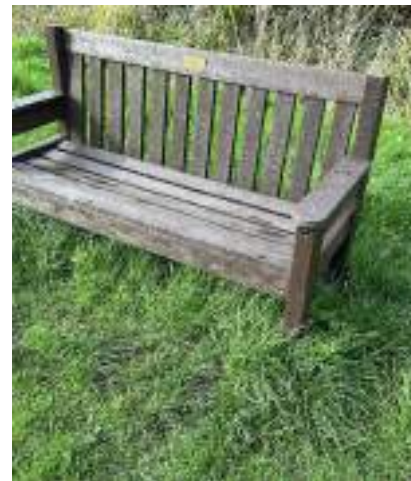
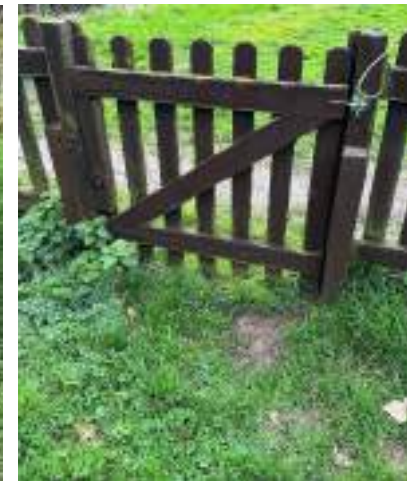
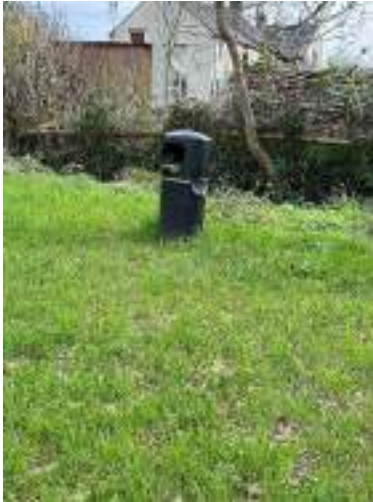
4.11 Barriers, Boundaries, Benches & Bins

The gates are self-closing, and the mechanism is working effectively.

Fencing and gates are in reasonable condition and are being well maintained.

There are several nearby bins and a variety of benches around the site in reasonable condition.
