Title: Review of footway crossfall

Location: A35 Chideock, Dorset

Date: 19/02/20

Author: Nick Reed IEng MCIHT| Safety Engineering Team Manager Operations

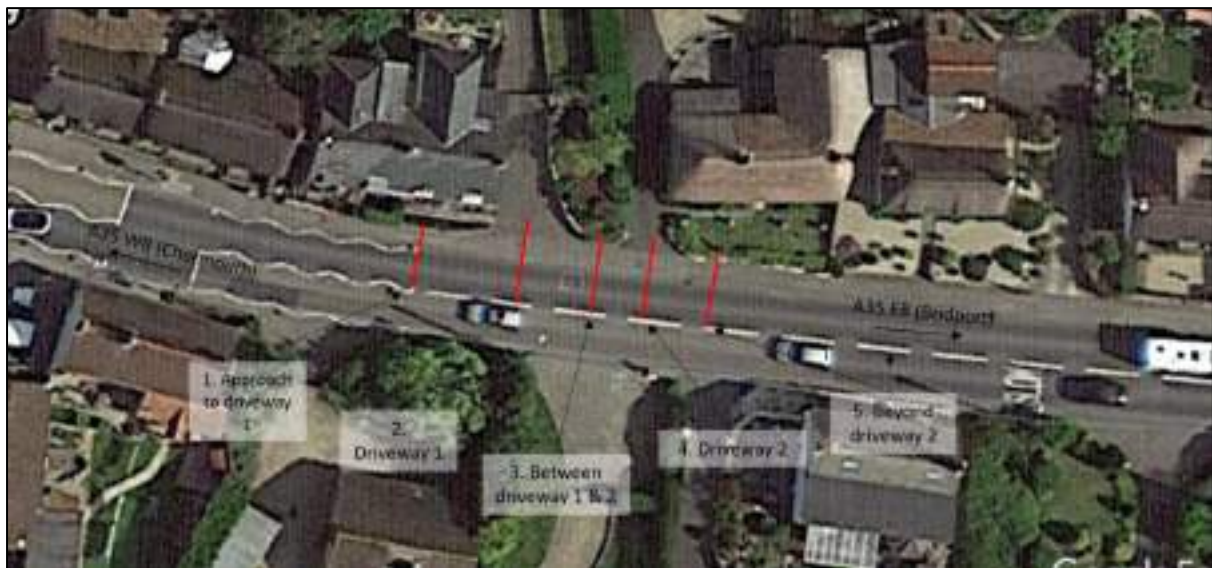
Figure 1, Chideock footway cross section locations

Five cross sections were assessed over the 25metre length utilising LiDAR from the AVIS system. (**Appendix 2**)

‘Driveway 1’ currently has the steepest crossfall at 1 in 5.6 (18%), followed by ‘Driveway 2’ at 1 in 6.4 (16%).

The shallowest crossfall was ‘Beyond driveway 2’ at 1 in 15.6 (6.4%).

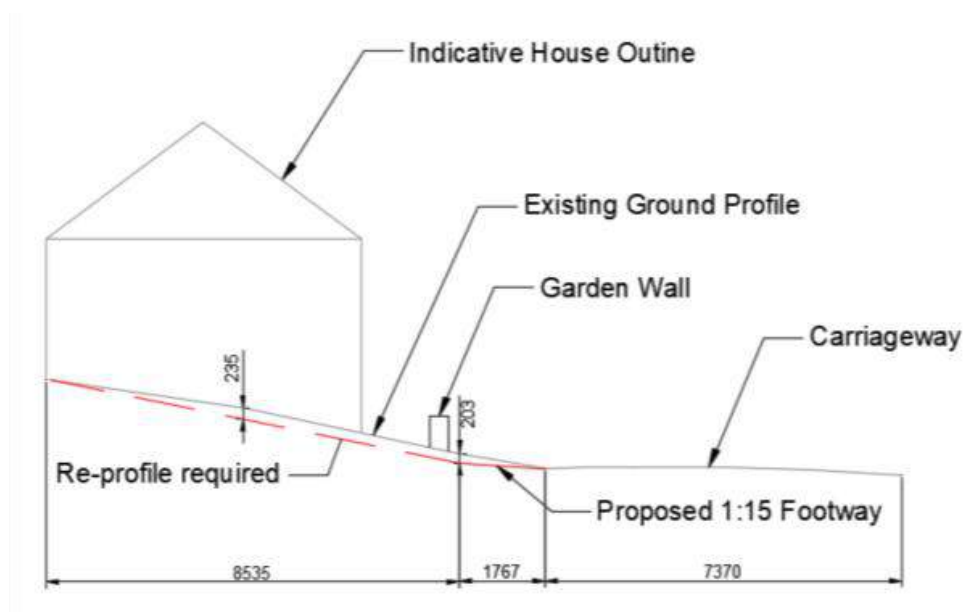
Figure 2, 1:15 footway crossfall and associated re-profiling

In reality, the ground continues to rise behind the rear of the footway to form private driveways. The resulting effect is that the tie in would need to be significantly extended into the private land to avoid creating a 'crease' where the back of the footway meets the driveways. This is further complicated by the presence of private dwellings bounding the driveways. **Figures 2 and 3** show the indicative reprofiling required for 1:15 & 1:40 cross falls.

As shown this would require significant modification to 3rd party land levels including utility services and building damp proofing.

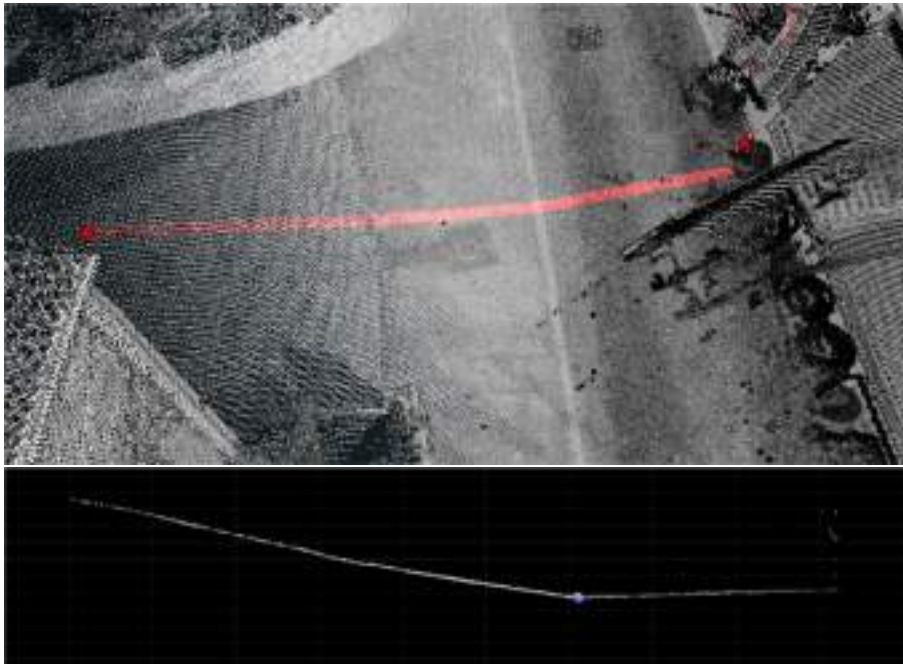
2. Driveway 1

Further assessing ‘Driveway 1’ as the ‘worst case scenario’, it is calculated that based on the current width of the pavement and design crossfalls, significant vertical adjustment will be needed to tie the footway into the driveway to achieve an acceptable crossfall. The table below shows the level of vertical adjustment required to meet the stated design crossfall. This would require either lowering the rear of the footway or raising the front of the footway.

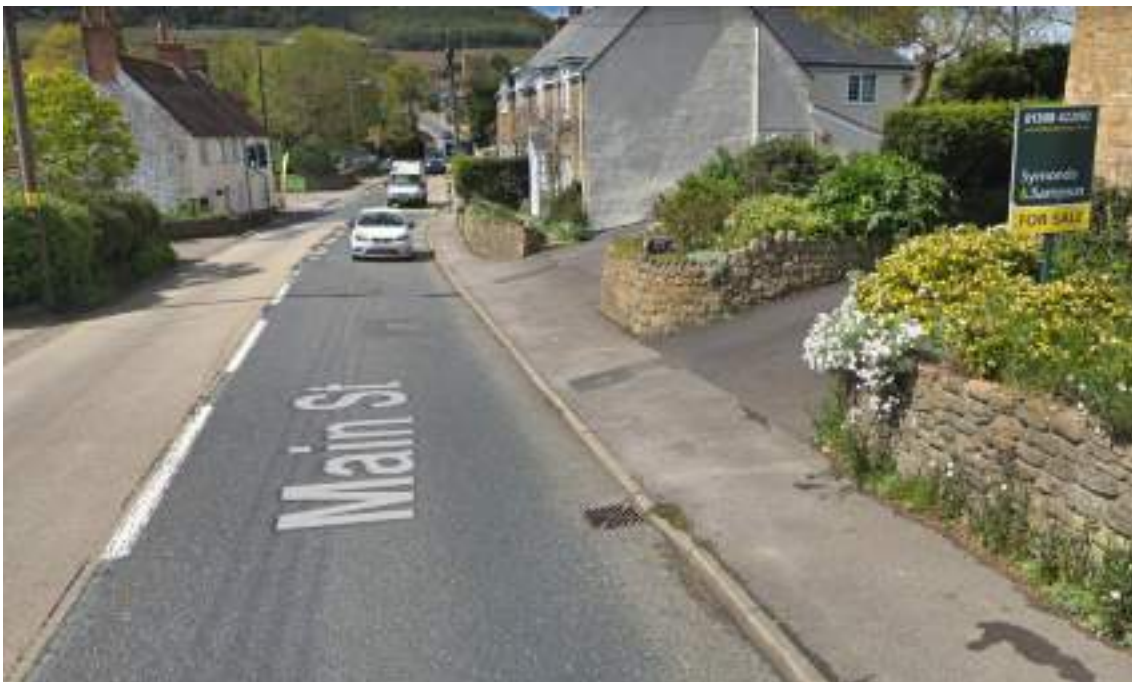
The issue occurs where the full height kerbs are lowered to provide vehicular access to private driveways that lead to properties that are significantly above the level of the footway. To provide an adequate change in vertical height from carriageway to the driveways, the footway must rise significantly over a relatively short distance due to the narrow footway. This has resulted in excessive cross fall. **(Appendix 3)**

View to the west showing footway crossfall

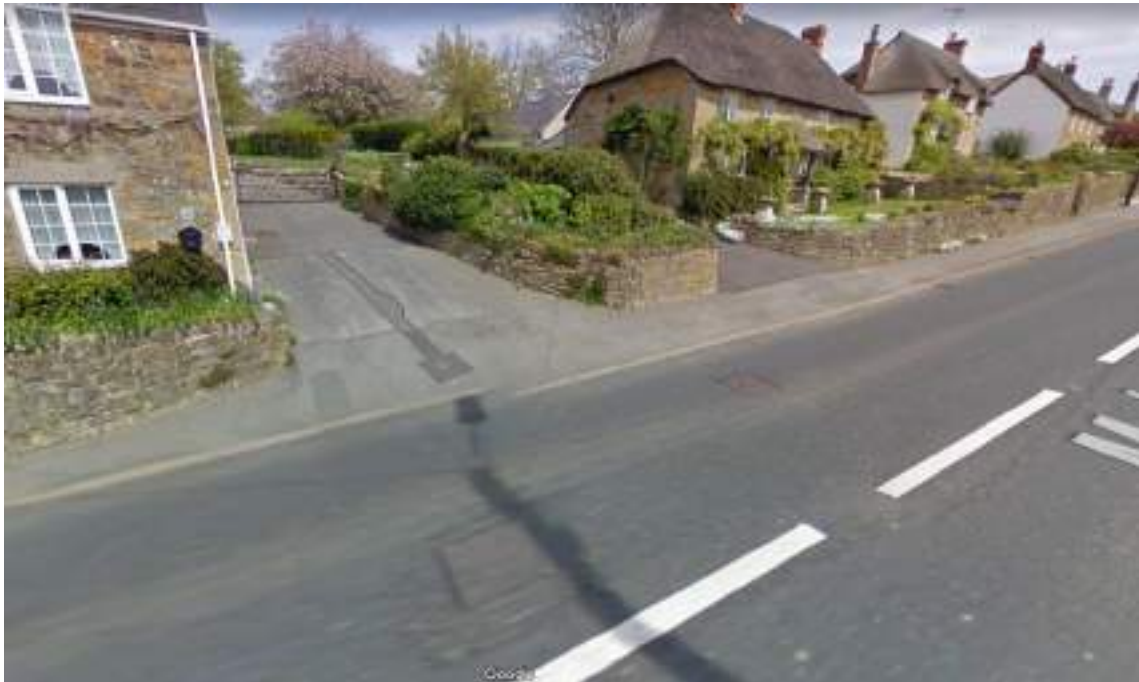
Visual inspection shows that there is no footway or hard strip on the southern side of the A35 negating the ability to slew the carriageway within the curtilage of the highway (**Appendix 3**) and there are private properties abutting the carriageway along the length of the southern side.

View to driveways 1 and 2 from southern side of carriageway
