A35 CHIDEOCK COMMUNITY SEVERANCE AND PEDESTRIAN SAFETY SCHEME (AWN 141)

Feasibility Study

REPORT NUMBER: 70035407/CHD/FEA/1/2

DATE: JANUARY 2019

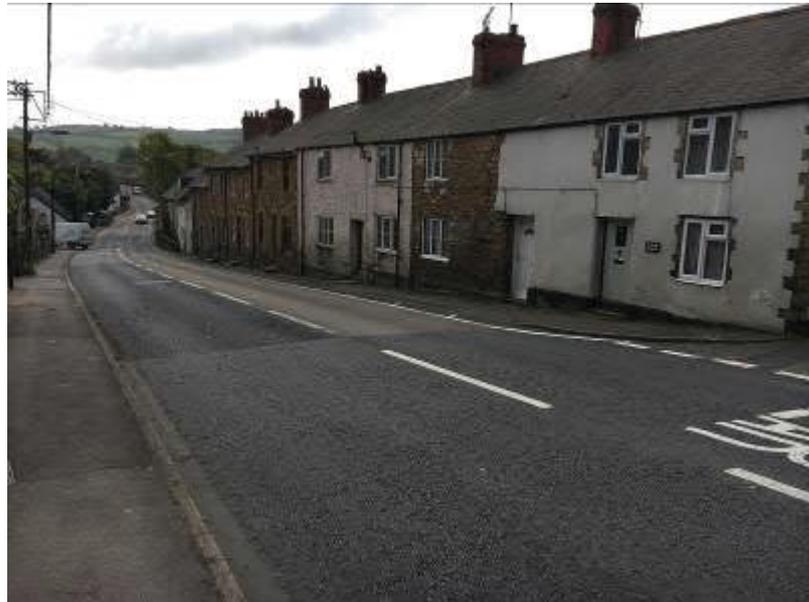
- 2.1.7. The A35 trunk road within the study area is a single carriageway road with longitudinal dashed 'warning line' road markings provided in the centre of the carriageway separating the eastbound and westbound traffic lanes for the majority of the extents of the 30mph speed limit, as shown on Photograph 1 (apart from in the vicinity of a traffic signal controlled pedestrian crossing facility where zig-zag road markings are provided in the centre of the carriageway, in accordance with the guidance stated in the Traffic Signs Manual).

Photograph 1 – Longitudinal road markings in the centre of the A35 carriageway

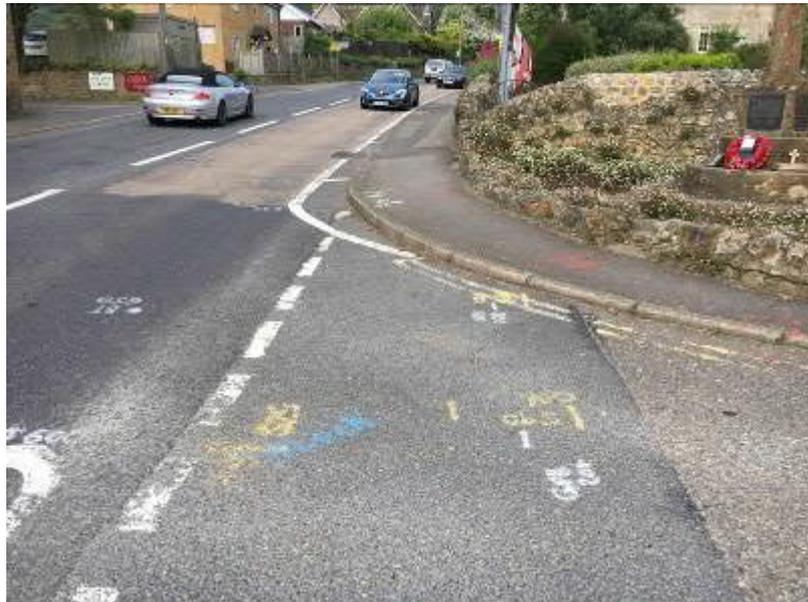
- 2.2.1. Within Chideock there is a continuous footway on the northern side of the A35 that is provided between the western end of the 30mph speed limit and the Park Farm access (located near the eastern end of the village, as shown on Figure 3). The footway on the north side of the A35 through Chideock is provided for a length of approximately 800m.
- 2.2.2. The footway on the north side of the A35 crosses a major/minor priority junction (North Road, as shown on Figure 3) as well as several private accesses. It was observed during the site visit on 18th May 2018 that, at the junction with North Road, dropped kerbs are only provided on the east side of the junction bellmouth by the entrance into the adjacent church (and no tactile paving is provided on either side of the junction to assist partially sighted pedestrians) – see Photograph 2.

Photograph 2 – Lack of dropped kerbs on the west side of the North Road junction

- 5.1.31. The lack of tactile paving on both sides of the North Road and Duck Street junctions could increase the difficulty for visually impaired pedestrians to cross these side roads. In addition, as stated in Paragraph 2.2.5 of this report, the southern footway crosses the Foss Orchard junction (which was observed to be used frequently by vehicles), and it is considered that the provision of tactile paving on the footway on both sides of this junction could increase the conspicuity of this junction to visually impaired pedestrians.

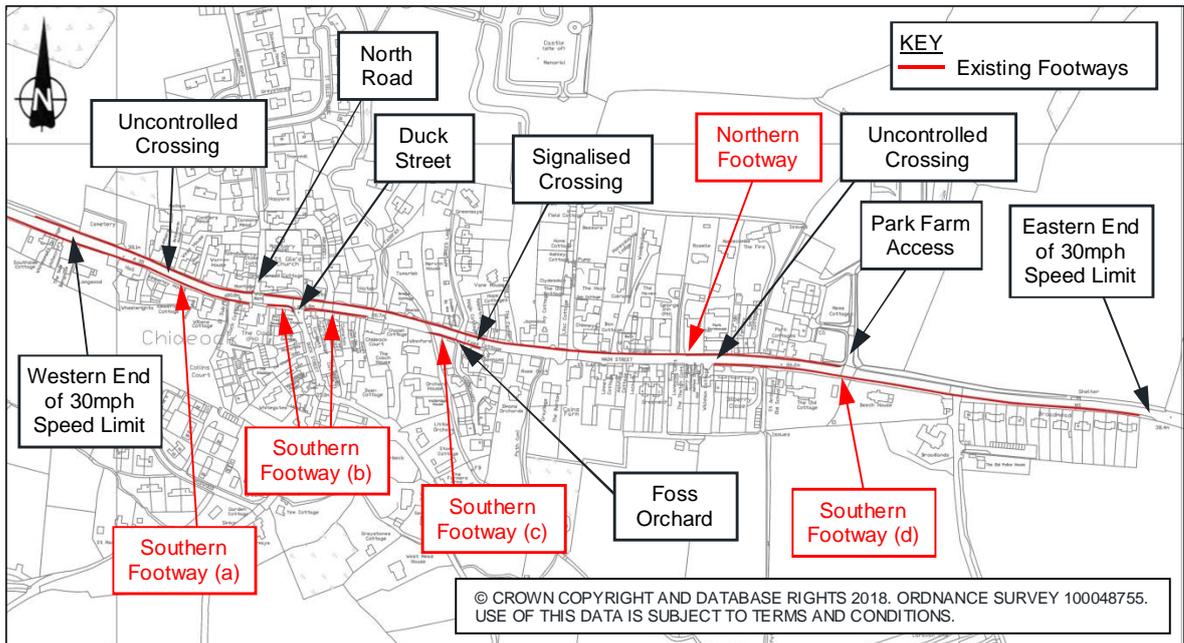
2.2.4. Figure 3 shows the locations of the existing footways located adjacent to the A35 through Chideock.

Figure 3 – Existing Footway Locations

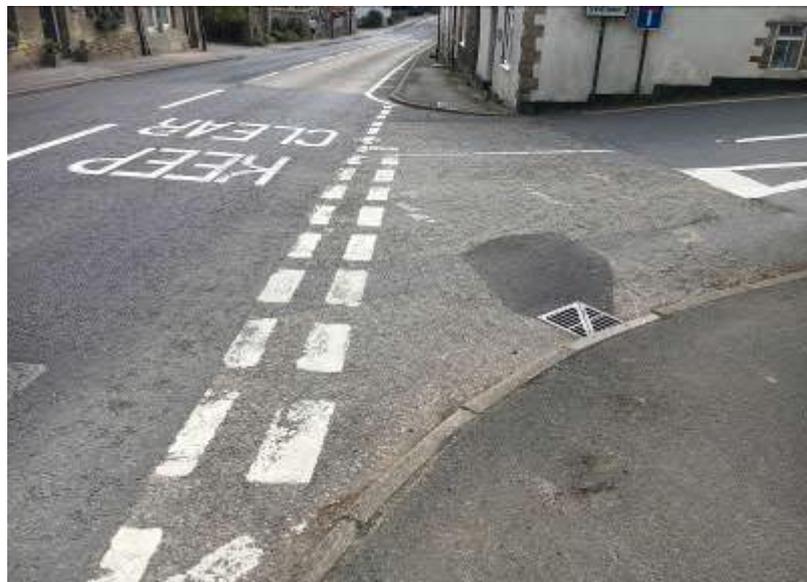
2.2.5. On the south side of the A35, the various footways cross several private accesses. The southern footway section (b) crosses a major/minor priority junction (Duck Street). No dropped kerbs or tactile paving are currently provided on either side of this junction to assist visually or mobility impaired pedestrians, as shown on Photograph 3.

Photograph 3 – Lack of dropped kerbs on both sides of the Duck Street junction

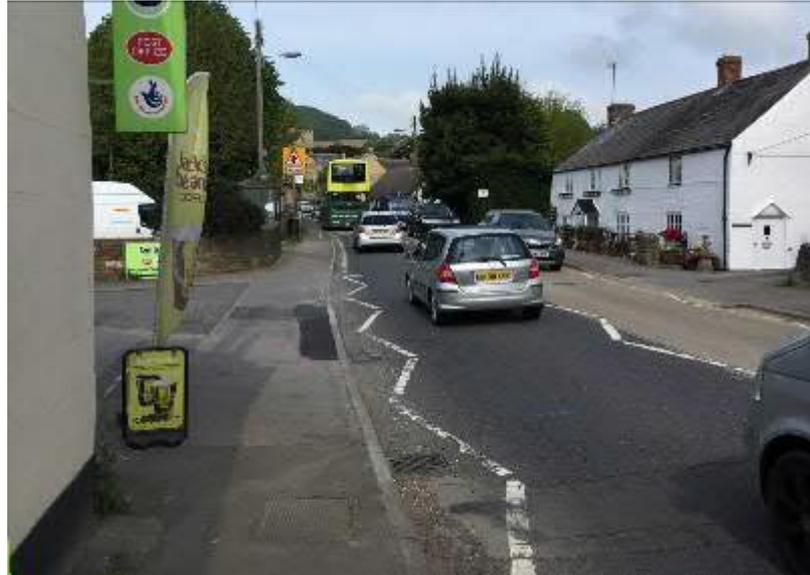
2.2.6. The southern footway section (c) in the vicinity of the Post Office crosses the Foss Orchard access junction (see Photograph 4). It was observed during the site visits that this junction is frequently used by vehicles turning into and out of the access, primarily to use the car park for the Post Office and the Central Convenience Store.

Photograph 4 – Southern footway crossing the Foss Orchard access junction

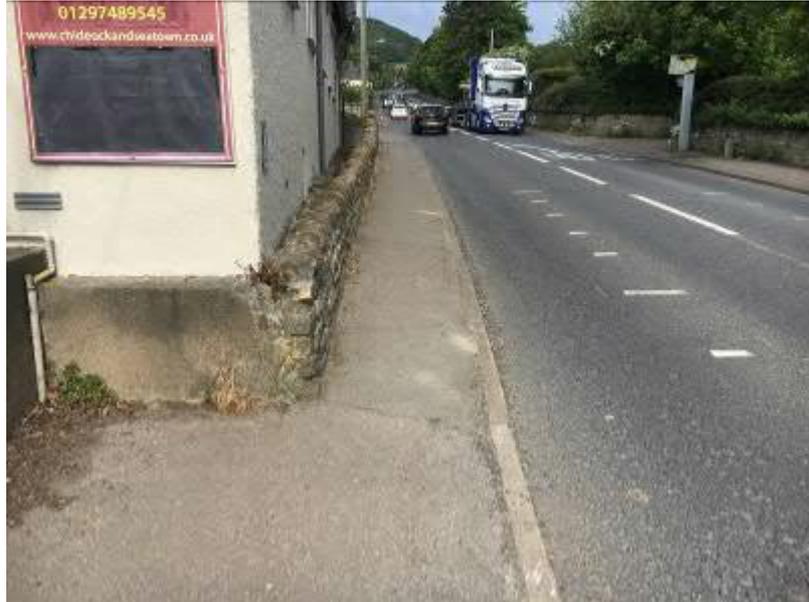
- 2.2.7. The footway located on the north side of the A35 carriageway within Chideock varies in width and is typically between 1.6m and 1.9m wide. Therefore, the widths of the northern footway conform with the acceptable minimum footway width of 1500mm (1.5m) stated in the Department for Transport (DfT) document “*Inclusive Mobility*”.

Photograph 5 – Narrow section of footway beside Chideock Village Hall

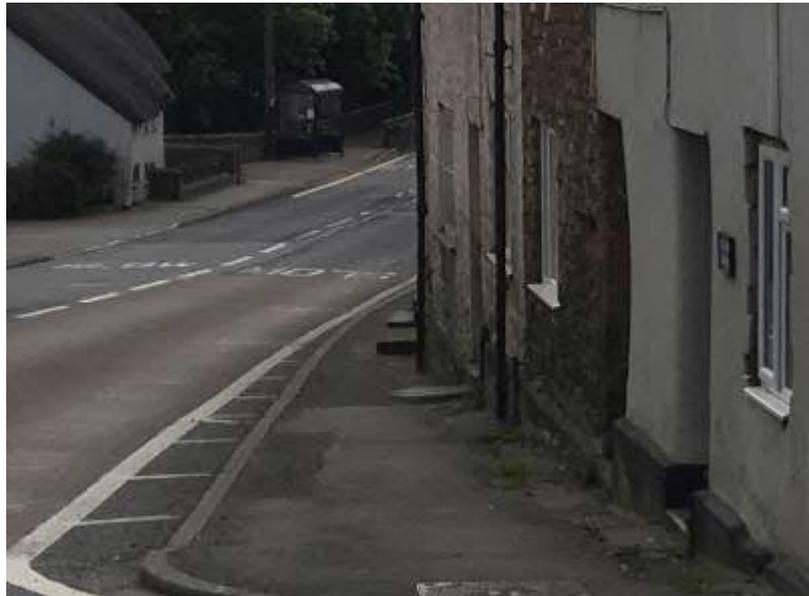
Photograph 6 – Narrow section of footway to the east of the Duck Street junction

- Inadequate footway width in front of the terraced houses located to the east of the Duck Street junction, which also has raised steps for the doorways that are tripping hazards for pedestrians;

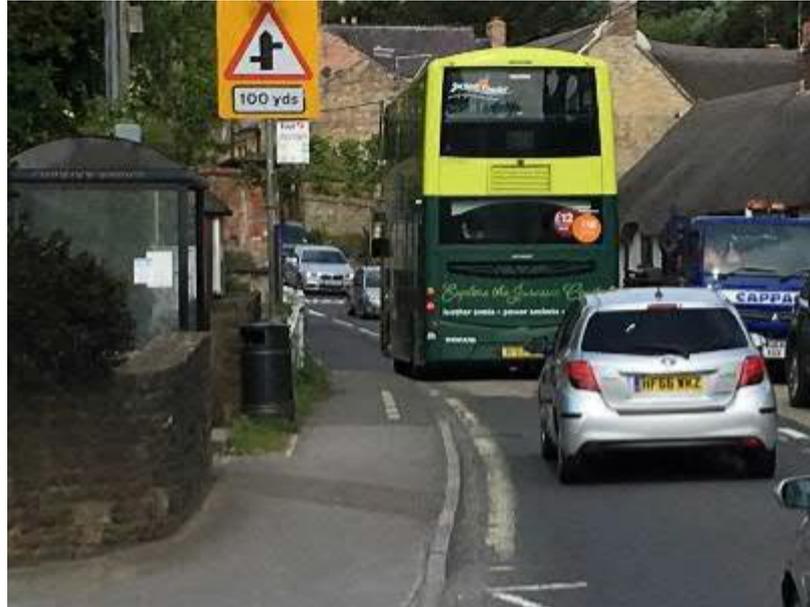
- 1.4m at the westbound bus stop adjacent to the Foss Orchard junction (as shown on Photograph 7).
- 2.2.9. It should be noted that the document “*Inclusive Mobility*” also states that the absolute minimum width of a footway is 1.0m, although footway widths between 1.0m and 1.5m should only be provided for a maximum length of 6m. All 3 locations listed above have footways that are less than 1.5m wide for lengths significantly in excess of 6m.

Photograph 7 – Narrow section of footway to the west of the Foss Orchard junction

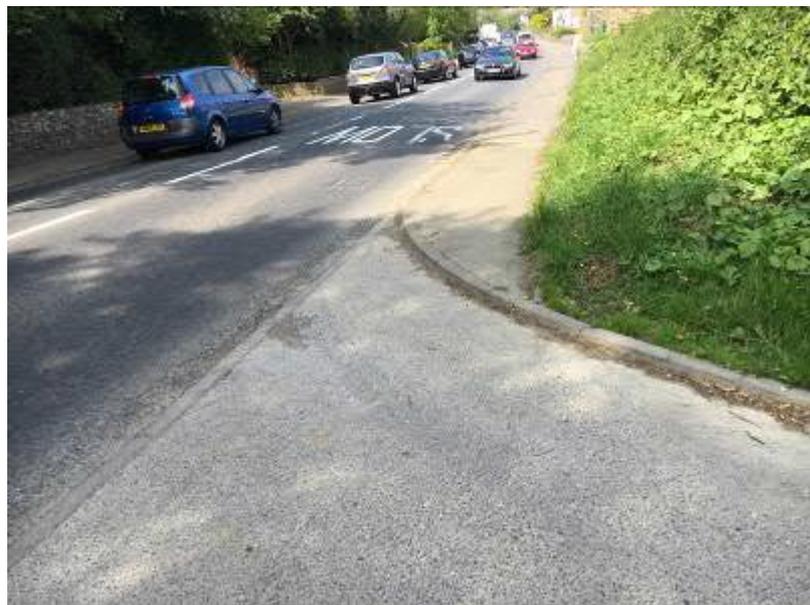
- 2.2.10. At the eastern end of the footway on the north side of the A35 carriageway, it was observed during the site visits that no dropped kerbs are provided where the footway ends (at the location of the access for Park Farm, where a ‘public right of way’ is provided). There are no other properties along the northern side of the A35 from this point eastwards. This lack of dropped kerbs could present a tripping hazard to mobility impaired pedestrians at the end of the footway.

Photograph 8 – Lack of dropped kerbs at the eastern end of the northern footway

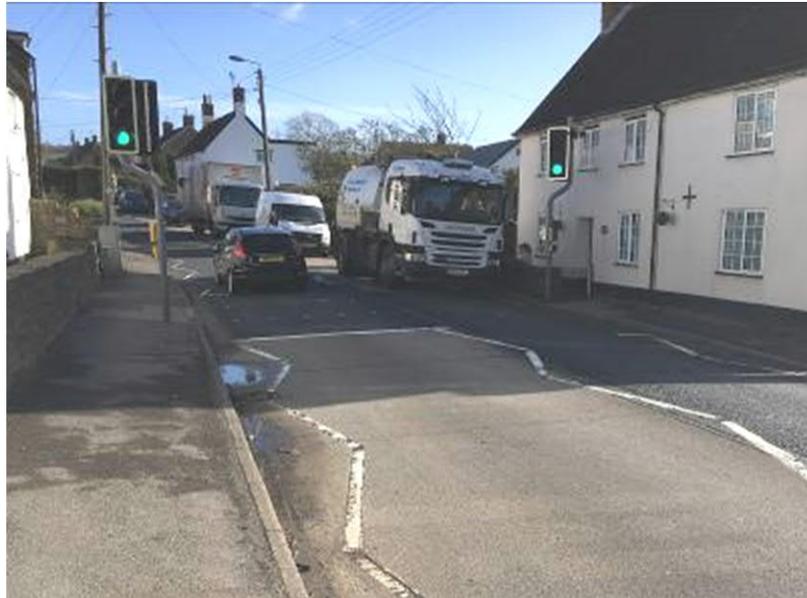
- 2.2.12. A traffic signal controlled pedestrian crossing facility is provided in the centre of the village, adjacent to the Post Office (as shown on Photograph 9).

Photograph 9 – Existing traffic signal controlled pedestrian crossing facility

- 2.2.15. In addition, it was observed on site that the forward visibility to the primary traffic signal head on the A35 eastbound approach to the signalised crossing facility is approximately 160m, and on the westbound approach the forward visibility to the primary signal head is approximately 180m. These distances are in excess of the Desirable Minimum Stopping Sight Distance (SSD) of 70m for a road with a design speed of 50 kph (30 mph).

- 2.2.16. It was observed during the site visits that both of the crossing points at the existing signalised pedestrian crossing facility conform with the requirements for mobility / visually impaired users at crossing facilities, as described in the Department for Transport (DfT) document *"Inclusive Mobility"* (i.e. they include dropped kerbs with a maximum 6mm kerb upstand and tactile paving with a colour that contrasts with the adjacent footway surfacing). It should be noted that the crossing points are currently buff in colour when the DfT document *"Guidance on the Use of Tactile Paving Surfaces"* recommends that red coloured tactile paving should be used (except where a crossing facility is provided in a conservation area where relaxations of the colour requirements are acceptable, and it is understood that Chideock is located in a conservation area).

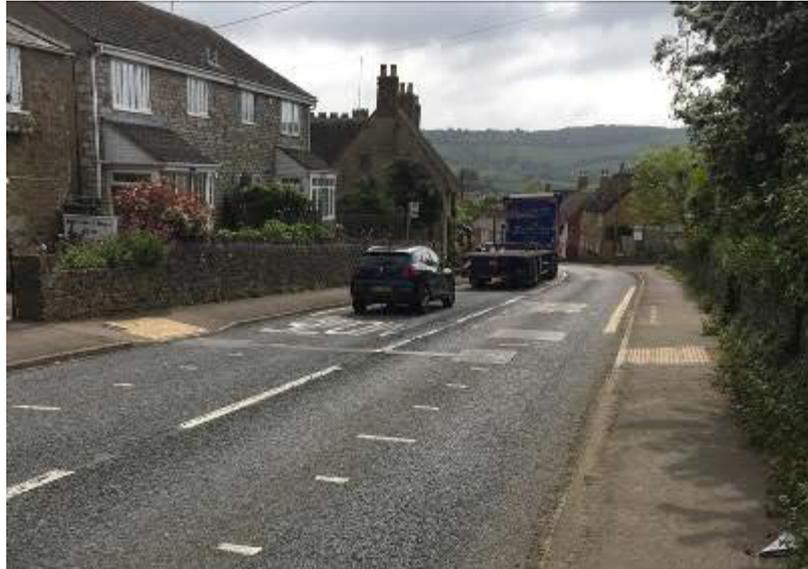
- Adjacent to the eastbound and westbound bus stops at the western end of the village (near the village hall) – see Photograph 10;
- Between the eastbound and westbound bus stops (approximately 40m to the east of the George Inn public house) – see Photograph 11.

Photograph 10 – Existing uncontrolled crossing facility near the village hall

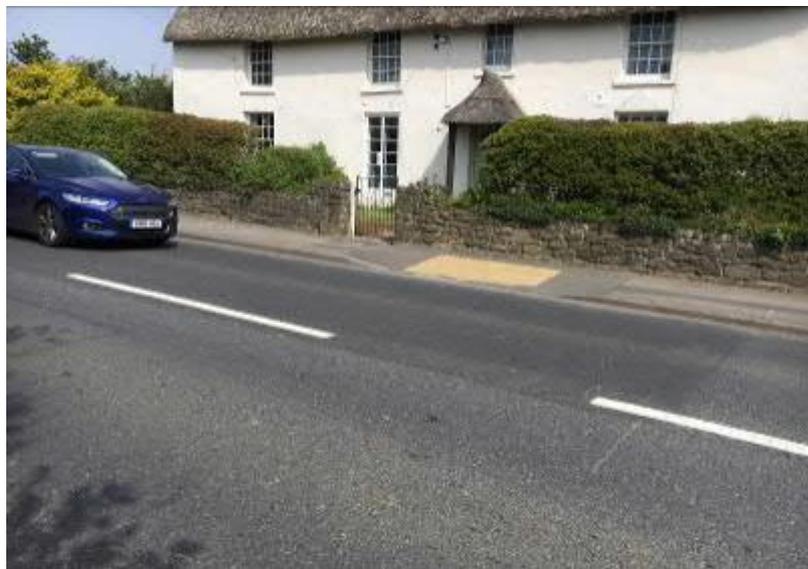
Photograph 11 – Existing uncontrolled crossing facility to the east of the George Inn

- 2.2.19. At the pedestrian crossing facility to the east of the George Inn (shown on Photograph 11), it was observed that the visibility in all directions from both crossing points appeared to be at least 70m (from an 'x' distance of 1.5m back from the kerbline), which is the preferred minimum visibility distance for pedestrian crossing facilities on a road with design speed of 50 kph (30 mph) as stated in the DMRB Advice Note TA 90/05 "*The Geometric Design of Pedestrian, Cycle and Equestrian Routes*". Although it is noted that the visibility westwards from the crossing point on the south side of the A35 carriageway is partially obstructed by the adjacent traffic sign and telegraph pole, as shown on Photograph 12.

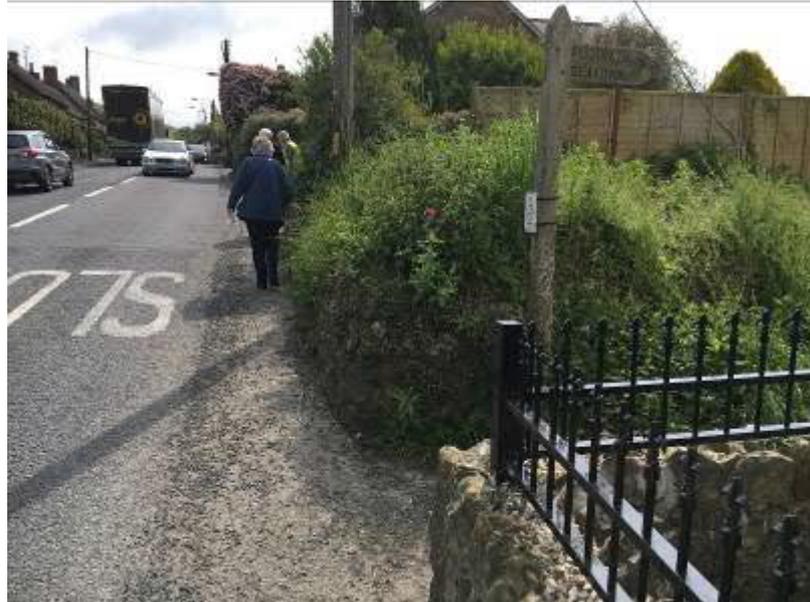
- 2.2.24. It was observed during the site visit that the visibility from the end of this footpath / bridleway of westbound vehicles approaching on the A35 is notably restricted by adjacent vegetation (although the visibility of approaching eastbound vehicles was adequate), and no footway is provided adjacent to the A35 carriageway at the entrance to the public footpath. It is understood that this footpath is used by pedestrians walking between Chideock and Seatown, as well as the caravan parks to the south of the village. The level of usage of this bridleway by equestrians is unclear.

Photograph 13 – Entrance onto the bridleway from the A35 in Chideock

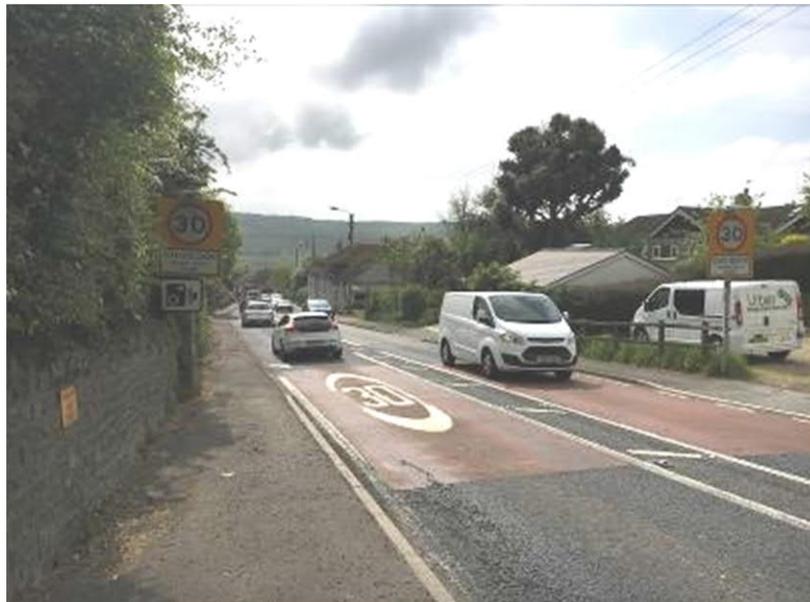
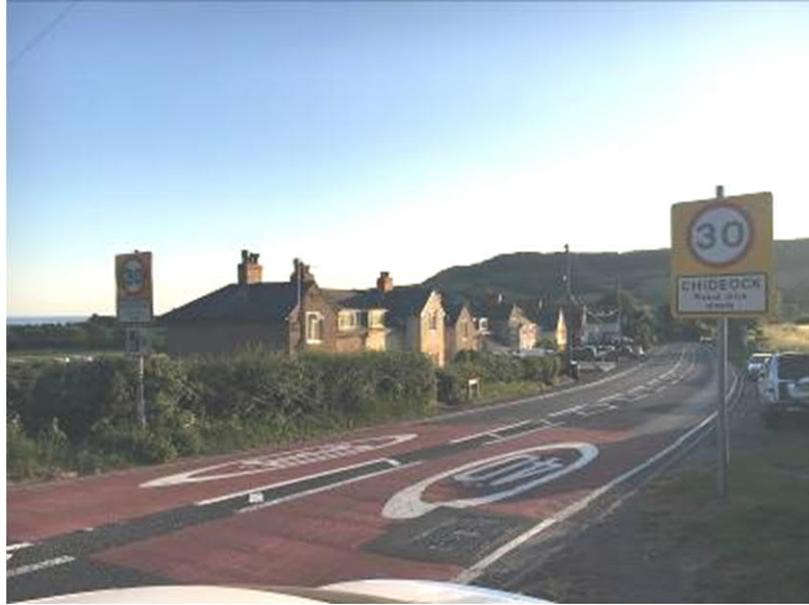
- 2.3.1. The A35 through Chideock has a permanent posted speed limit of 30mph, which commences just to the west of Chideock Village Hall and terminates at the eastern end of the built-up area of the village. Therefore the total distance of the 30mph speed limit is approximately 1 km). The terminal 30mph speed limit traffic signs at the both ends of Chideock are shown on Photographs 14 and 15.

Photograph 14 – Terminal 30mph speed limit signs at the western end of Chideock

Photograph 15 – Terminal 30mph speed limit signs at the eastern end of Chideock

- 2.3.2. It can be seen from Photographs 14 and 15 that the terminal 30mph speed limit traffic signs on yellow backing boards are supplemented with '30' roundel speed limit road markings in the eastbound and westbound directions appropriately. Photograph 14 also shows that the terminal 40mph speed limit signs at the western end of the village (exiting the built-up area) are not supplemented with a '40' roundel road marking.

- 5.1.23. It was observed during the site visit in May 2018 that the terminal 30mph speed limit traffic signage was appropriate and clearly visible to road users approaching Chideock at both ends of the village.

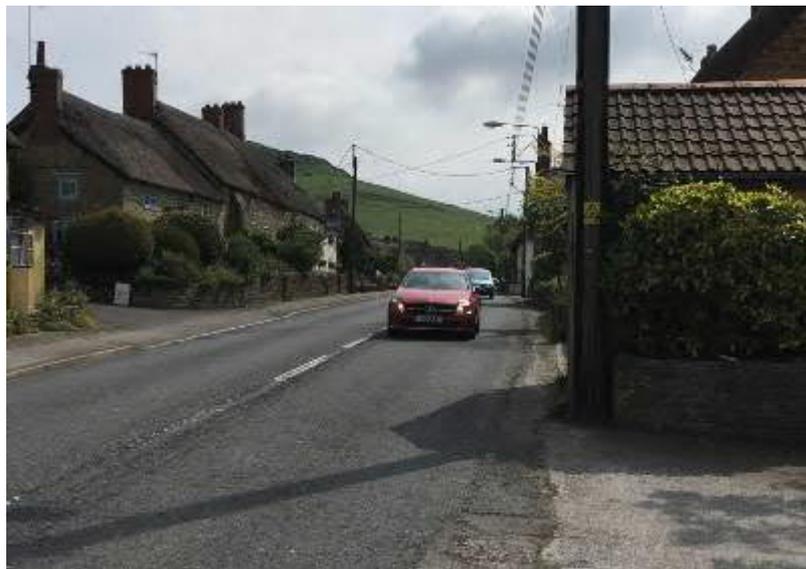
5.1.3. As identified in Section 2.2 of this report, on the south side of the A35 carriageway there is intermittent footway provision, with several sections where no footways are provided. The 30mph speed limit section of the A35 through Chideock is approximately 1.0 km long, of which footways are provided on the south side of the A35 carriageway for approximately 0.7 km. Consequently for approximately 0.3 km (300m) in total, there are no footways currently provided on the south side of the A35 in the village.

Photograph 16 – Lack of footway on the south side of the A35 carriageway

5.1.4. The possibility of providing lengths of footway on the south side of the carriageway has been considered, by potentially narrowing the carriageway width and the footway on the north side of the A35. However, due to the constraints of various residential properties on both sides of the A35 carriageway in these locations, it is unfeasible that the following cross-section geometric dimensions (in accordance with the mandatory requirements of the DMRB) can be provided if new footways are installed on the south side of the A35 carriageway (where they are not currently provided):

- 5.1.5. The possibility of providing a 'virtual footway' on the south side of the A35 has also been considered, as suggested by Dorset County Council. However this type of facility is not recognised in the DMRB as a feature that can be used on the trunk road network, and it is considered that it could be unsafe to encourage additional pedestrians to walk on the A35 carriageway taking into account the significant traffic volumes observed during the site visits. Therefore, this option has been discounted due to 'virtual footways' not being included in the DMRB as well as the potential road safety concerns relating to additional pedestrians being encouraged to walk in the A35 carriageway.

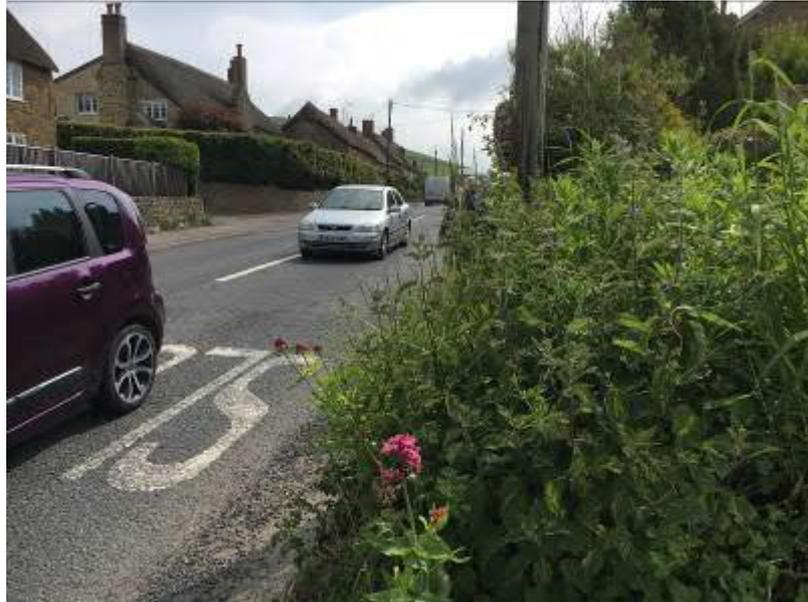
- 5.1.25. A public footpath / bridleway adjoins the A35 (on the south side of the carriageway) adjacent to the Rose Cottage B&B, in the centre of the village approximately 70m to the east of the Post Office.
- 5.1.26. As shown on Photograph 13 (in Section 2.2 of this report), pedestrians or equestrians egress directly onto the carriageway at the end of this footpath / bridleway. In addition, the visibility of westbound vehicles approaching on the A35 is notably restricted by adjacent vegetation, as shown on Photograph 17.

Photograph 17 – Restricted visibility of approaching westbound vehicles

5.1.27. Therefore the restricted visibility, and the lack of a footway on the south side of the A35 in this location, could increase the potential for a pedestrian being struck by a passing vehicle as they wait to cross the A35 carriageway in this location. In addition, there could be increased potential for an equestrian being struck by a passing vehicle as they wait to enter the A35 carriageway in this location, although it was observed during the site visit that this footpath did not appear suitable for equestrians to use (in terms of its width).

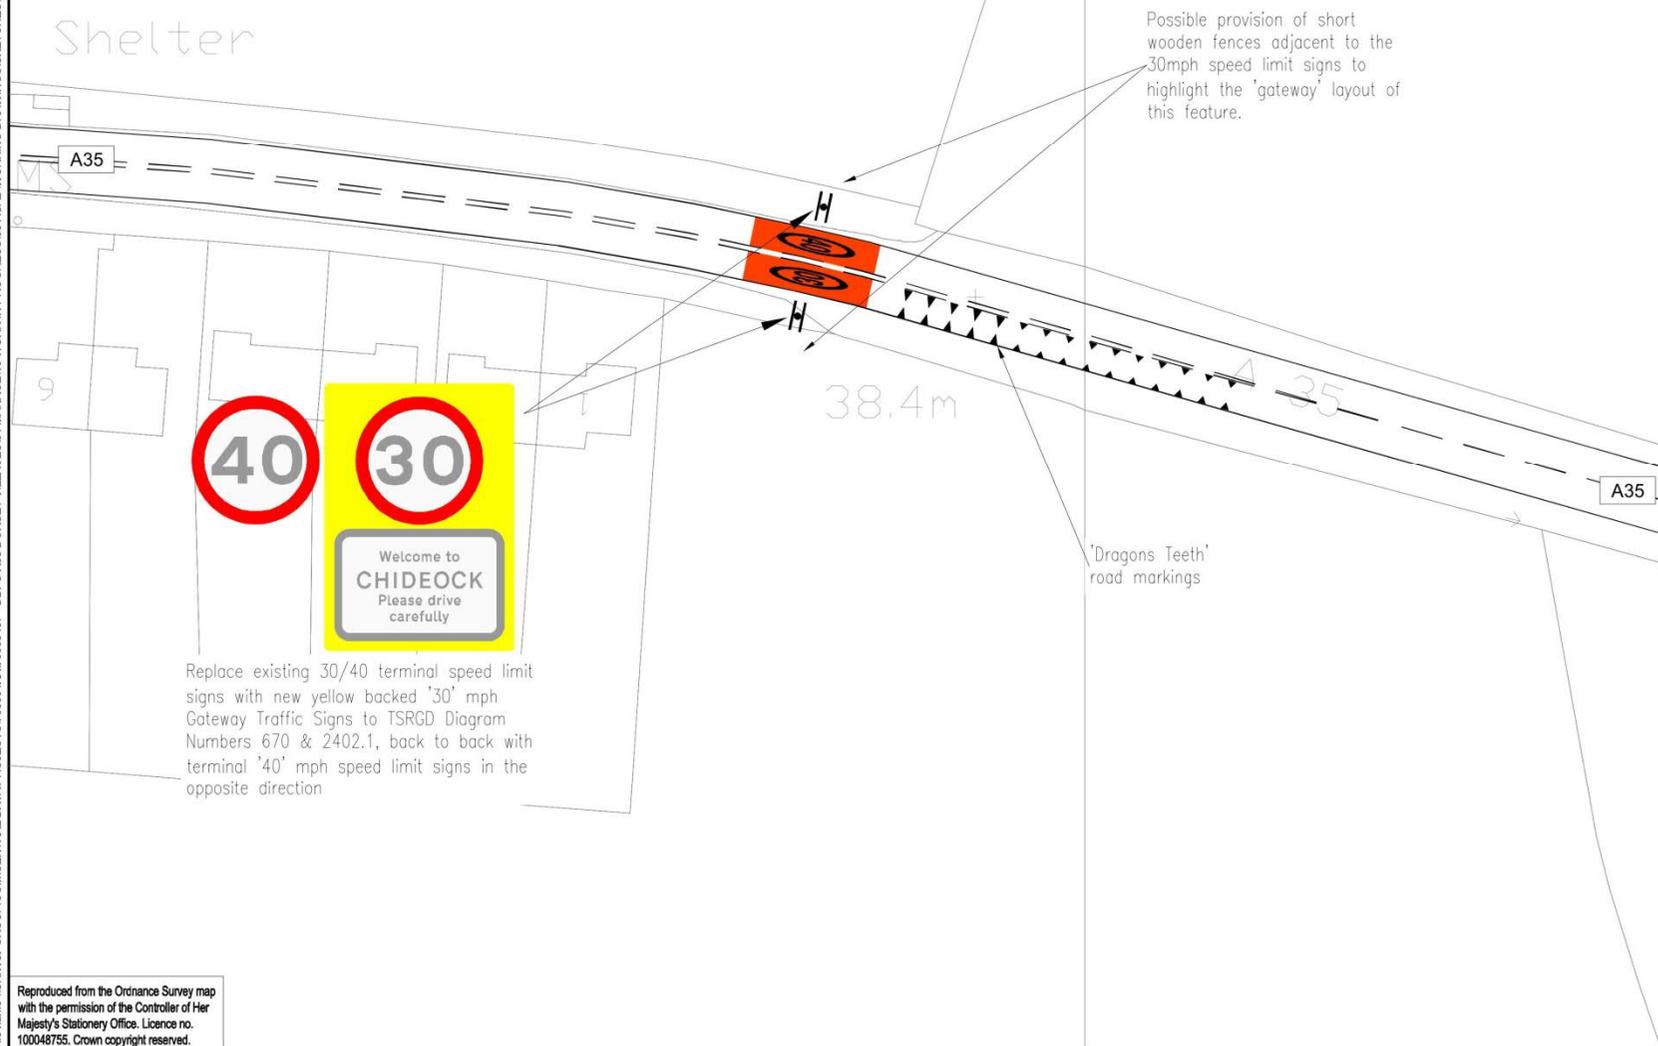
Replace existing 30/40 terminal speed limit signs with new yellow backed '30' mph Gateway Traffic Signs to TSRGD Diagram Numbers 670 & 2402.1, back to back with terminal '40' mph speed limit signs in the opposite direction

Possible provision of short wooden fences adjacent to the 30mph speed limit signs to highlight the 'gateway' layout of this feature.

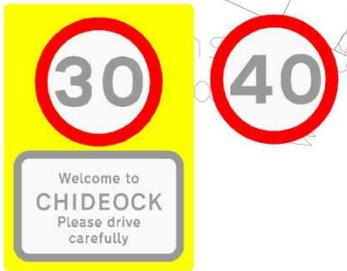
Replace existing 30/40 terminal speed limit signs with new yellow backed '30' mph Gateway Traffic Signs to TSRGD Diagram Numbers 670 & 2402.1, back to back with terminal '40' mph speed limit signs in the opposite direction
